PASCO COUNTY MPO

Micromobility Traffic Counts Strategic Plan & Data Collection

CTST Meeting: January 22, 2025

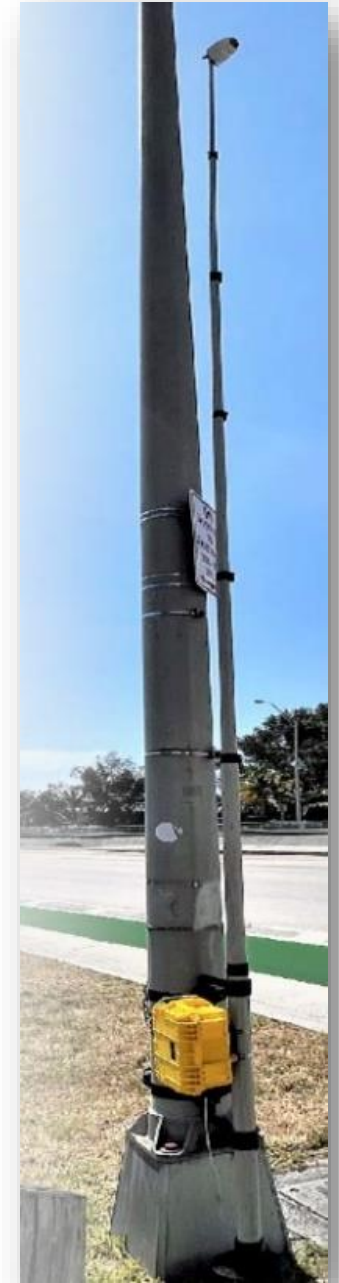
Smart Camera Data Collection

High-quality portable cameras capable of detecting and tracking multimodal classifications

- Vehicle, truck, bus, motorcycles, bike, ped, scooter

AI-Powered Analysis

- Volume, mode, directions, trajectory

Near-Miss Analysis

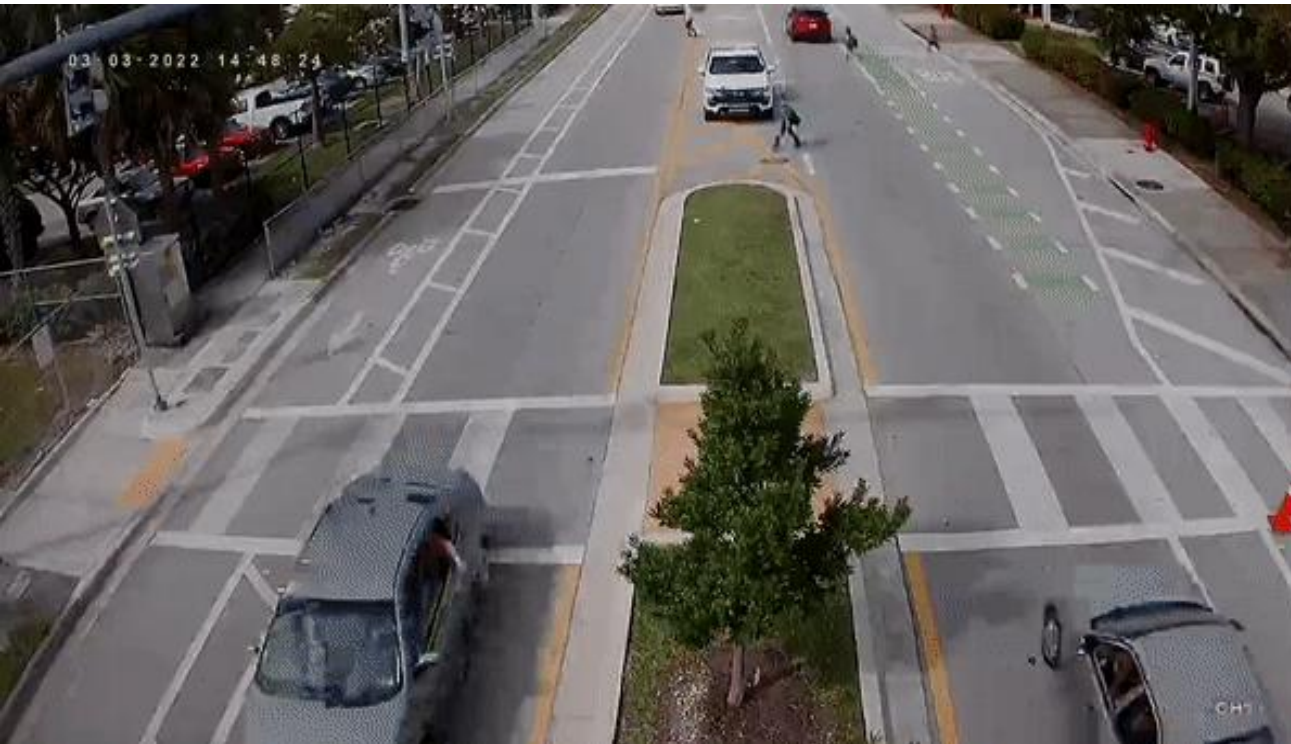
SMART CAMERA DATA COLLECTION

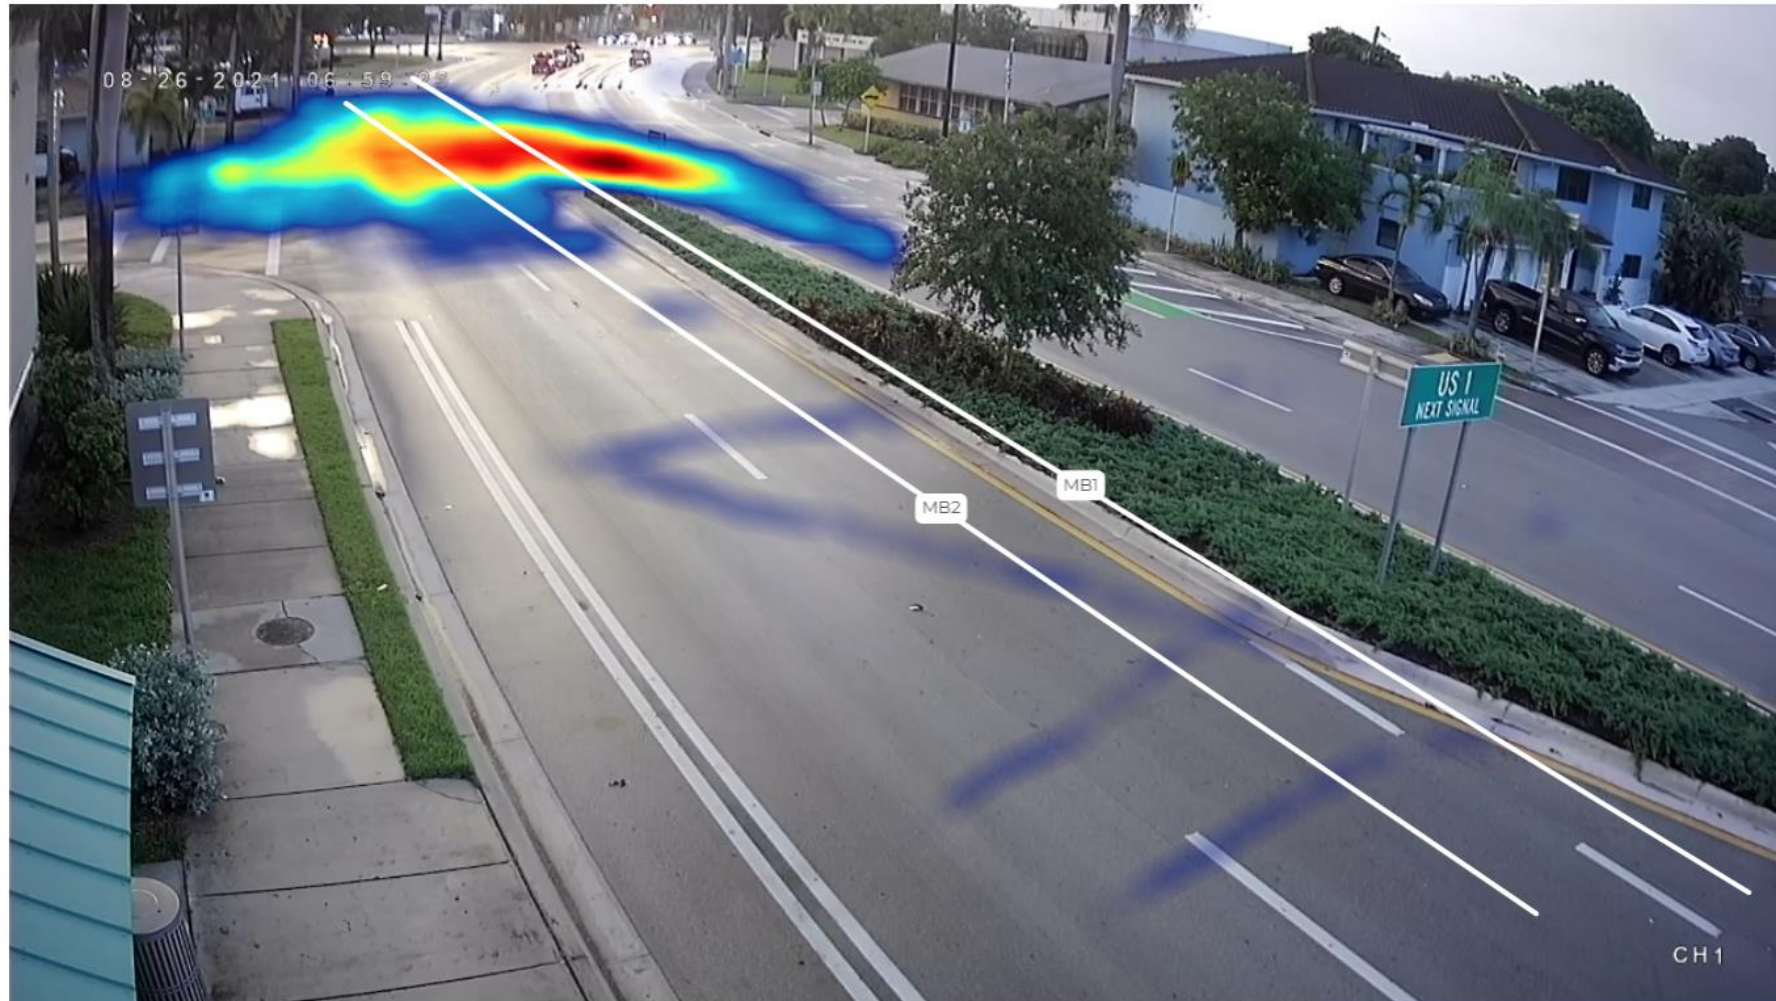
TRADITIONAL NEAR MISS TECHNOLOGY

What are collision points?

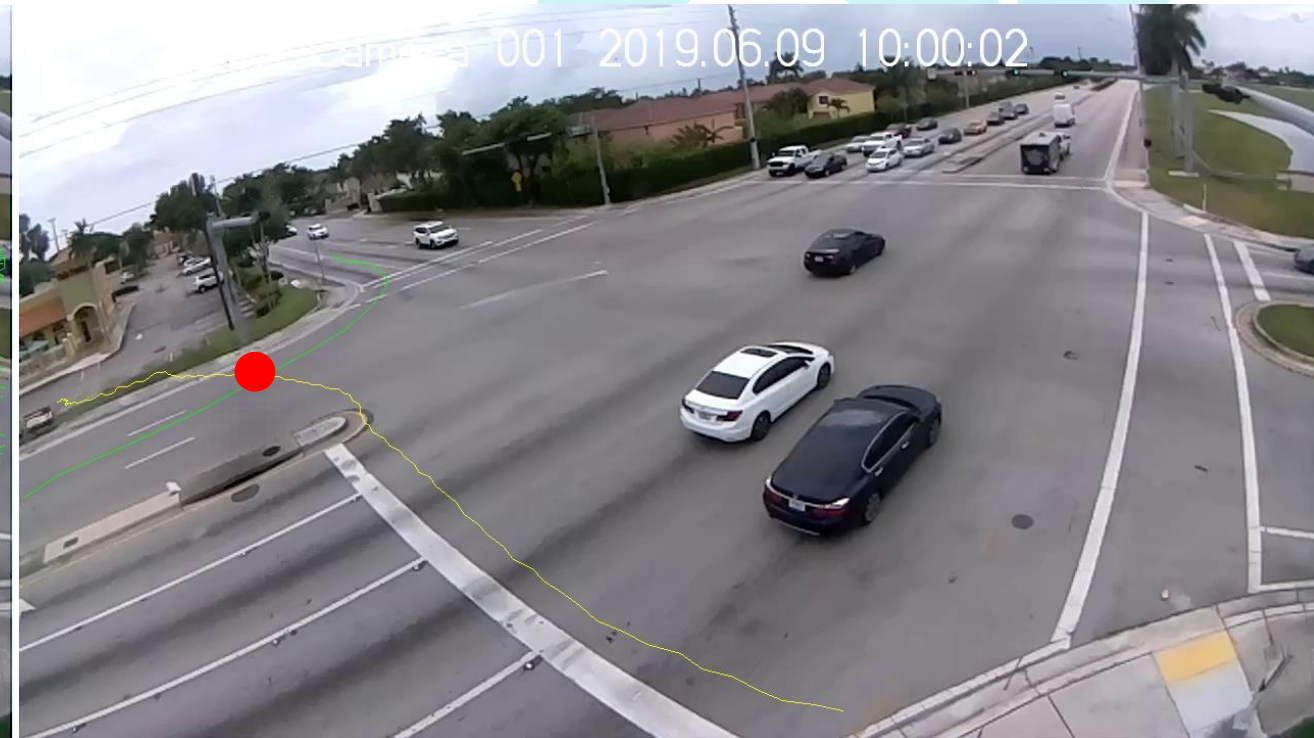
PREDICTIVE CRASH DETECTION

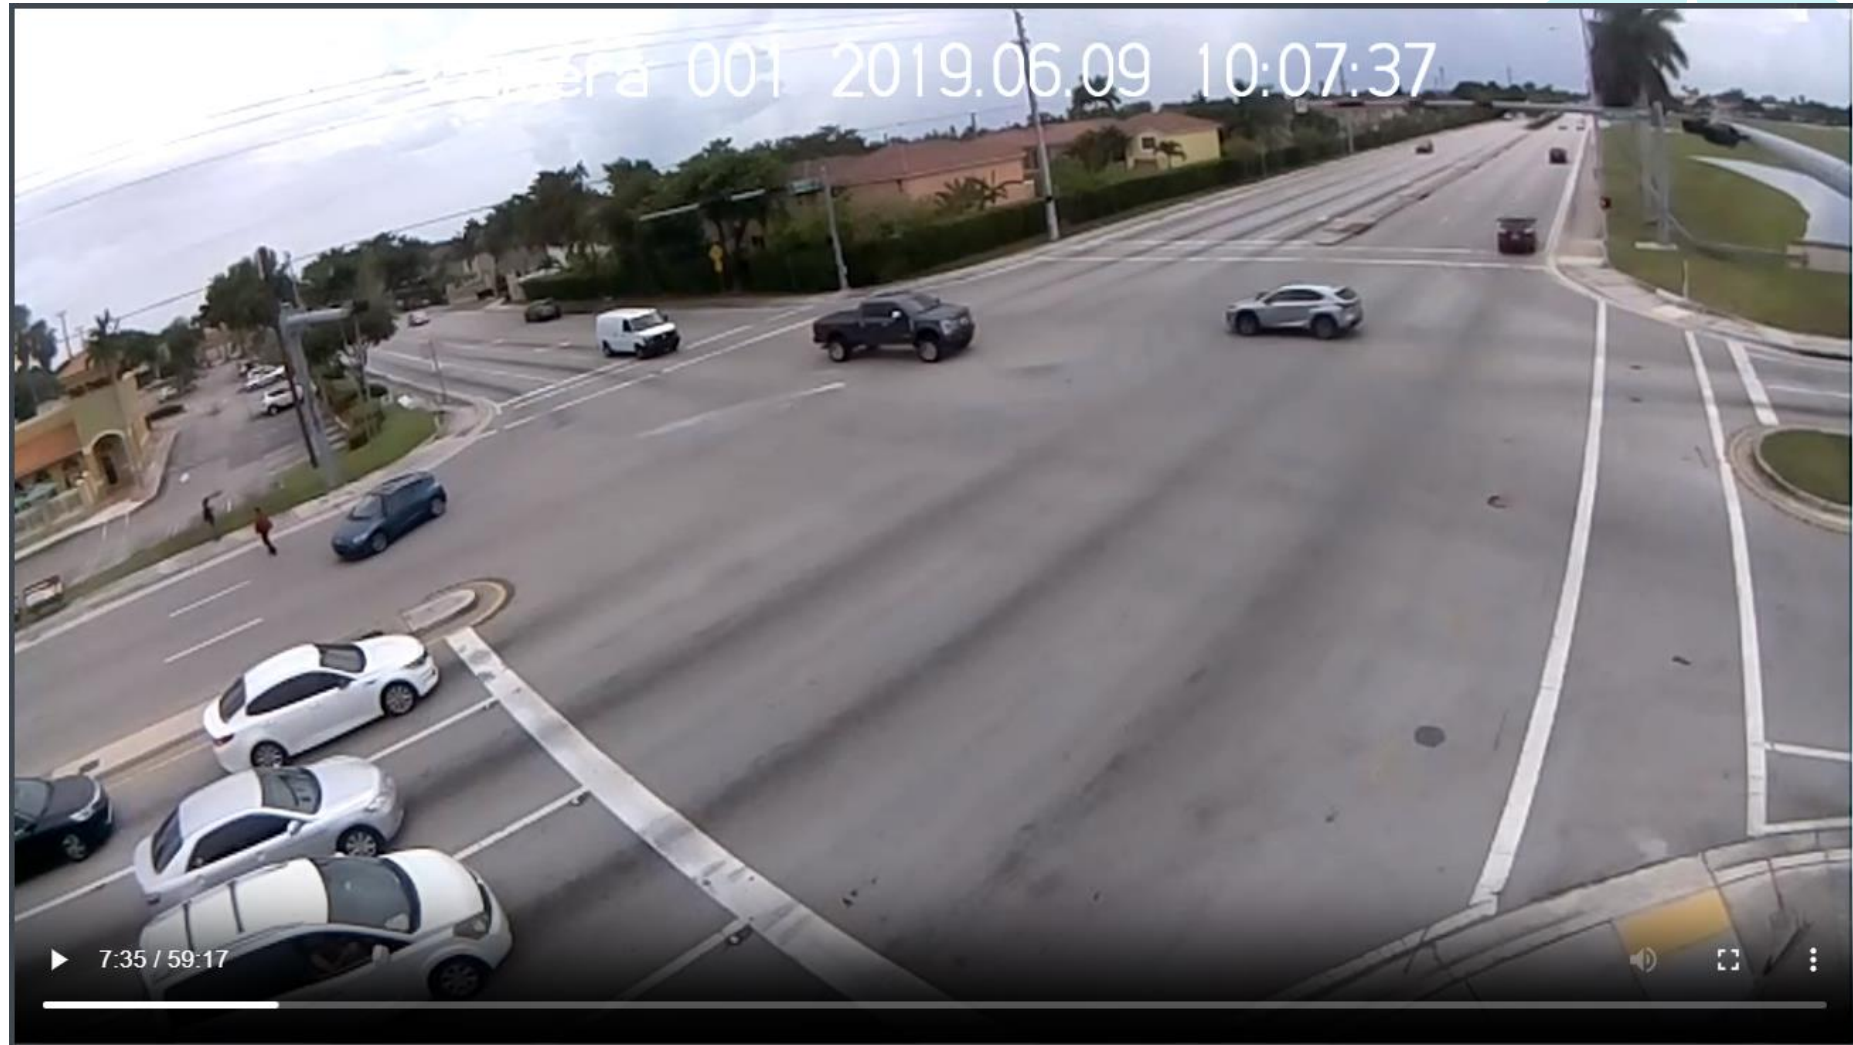
POST PROCESS VIDEO REVIEW

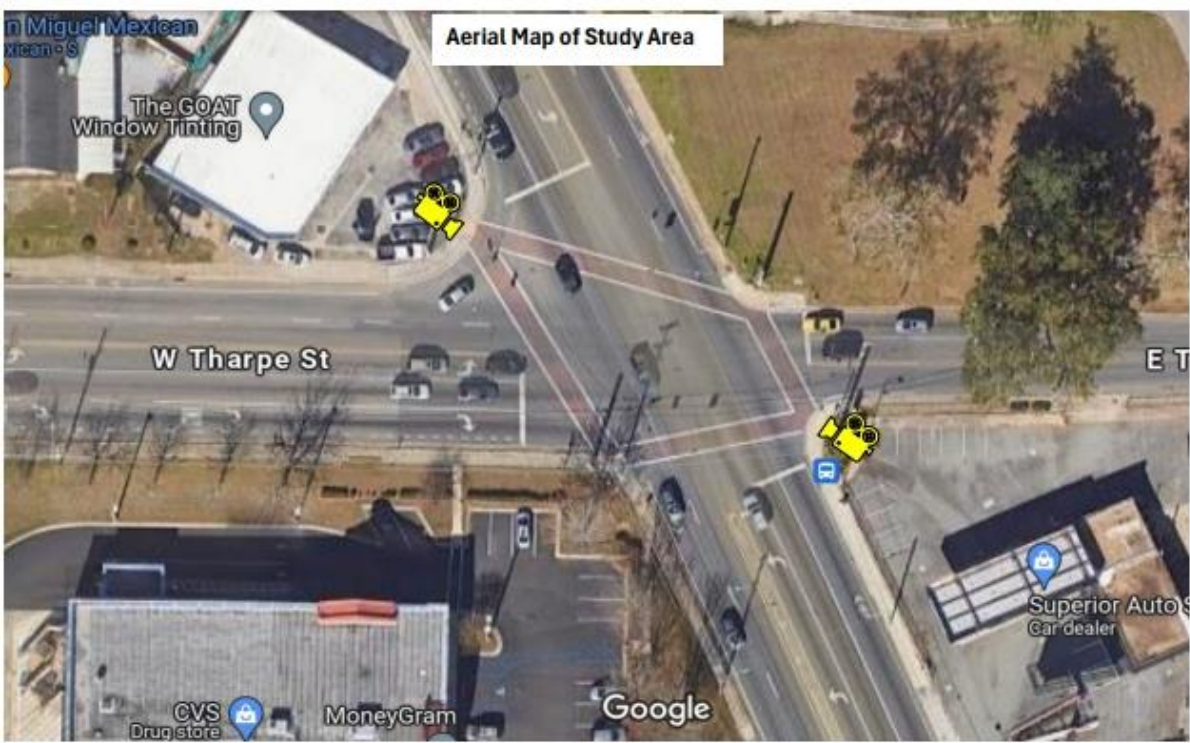
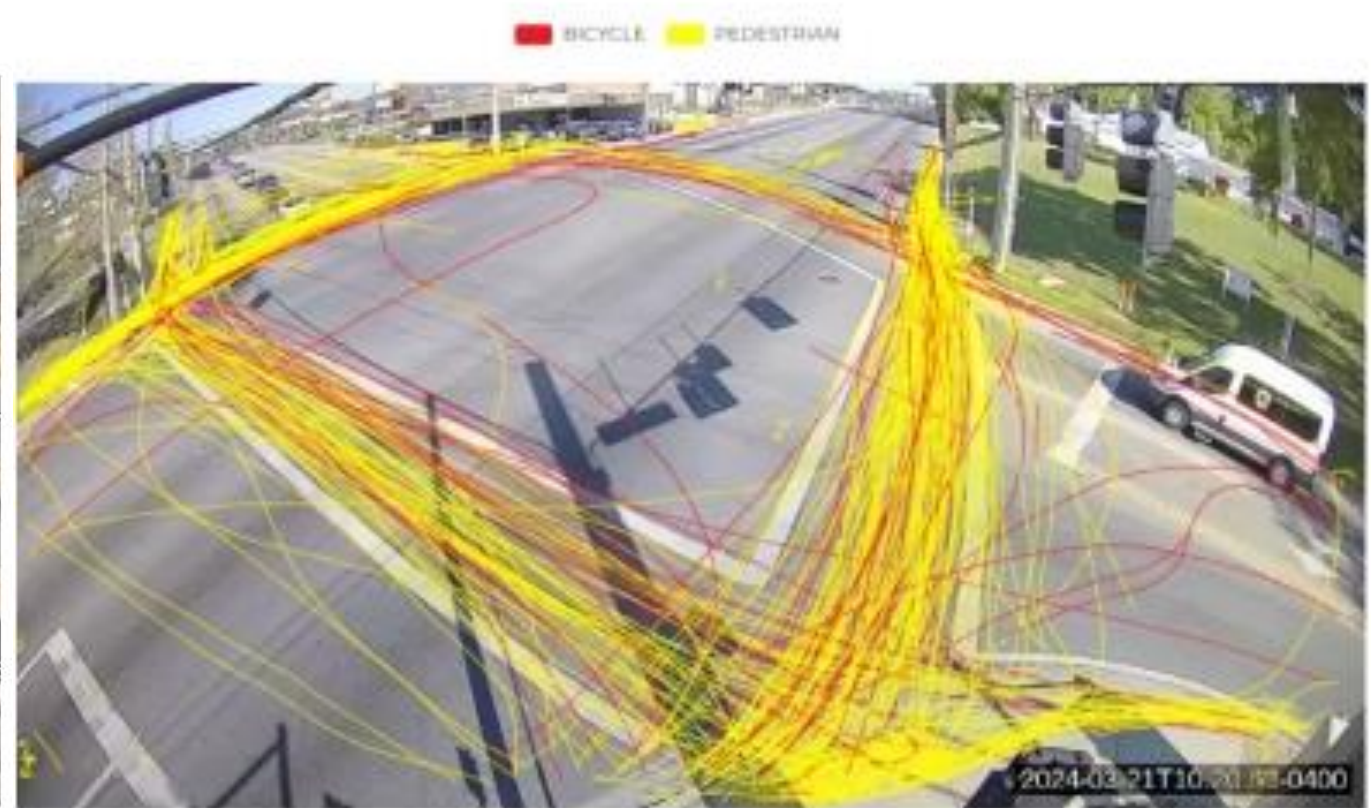
NEAR-MISS EXAMPLES

PEDESTRIAN AND BICYCLE NEAR-MISS ANALYSIS

Site Name:	US Hwy 27 and E Tharpe St	GPS:	30.463669, -84.282452
Camera Location:	NW and SE sidewalk	Location:	Tallahassee, Florida
Date Collection Period:	03/21/2024 and 03/23/2024	Count Type:	Video Object Detection

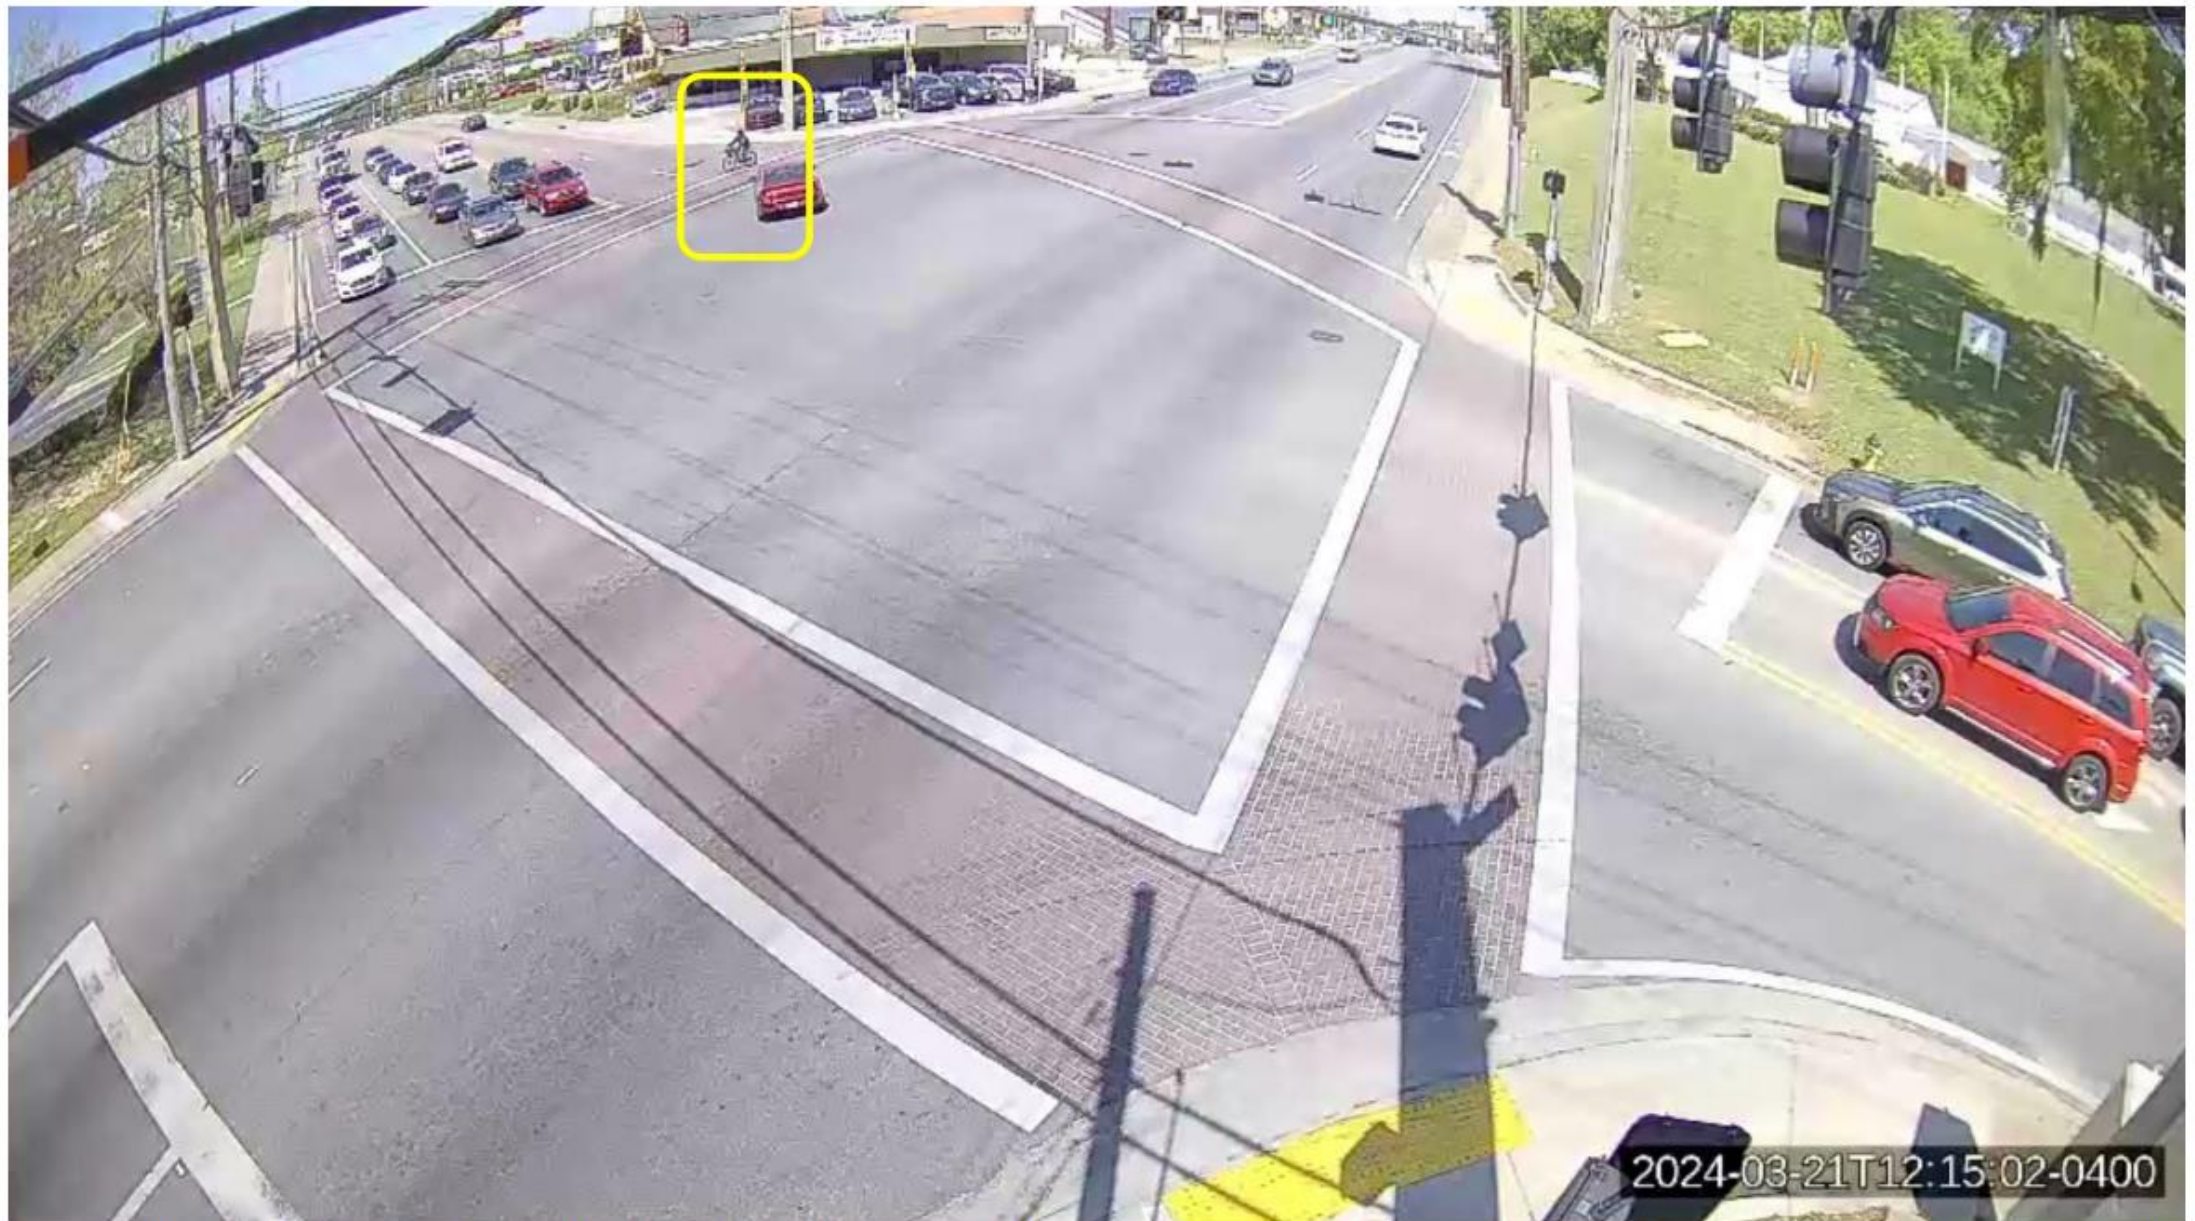
Figure 4: Another event in which a bicyclist using the west crosswalk properly travels near an incoming vehicle performing a left turn in the intersection. (Date 03/21/2024 at 12:15 PM)

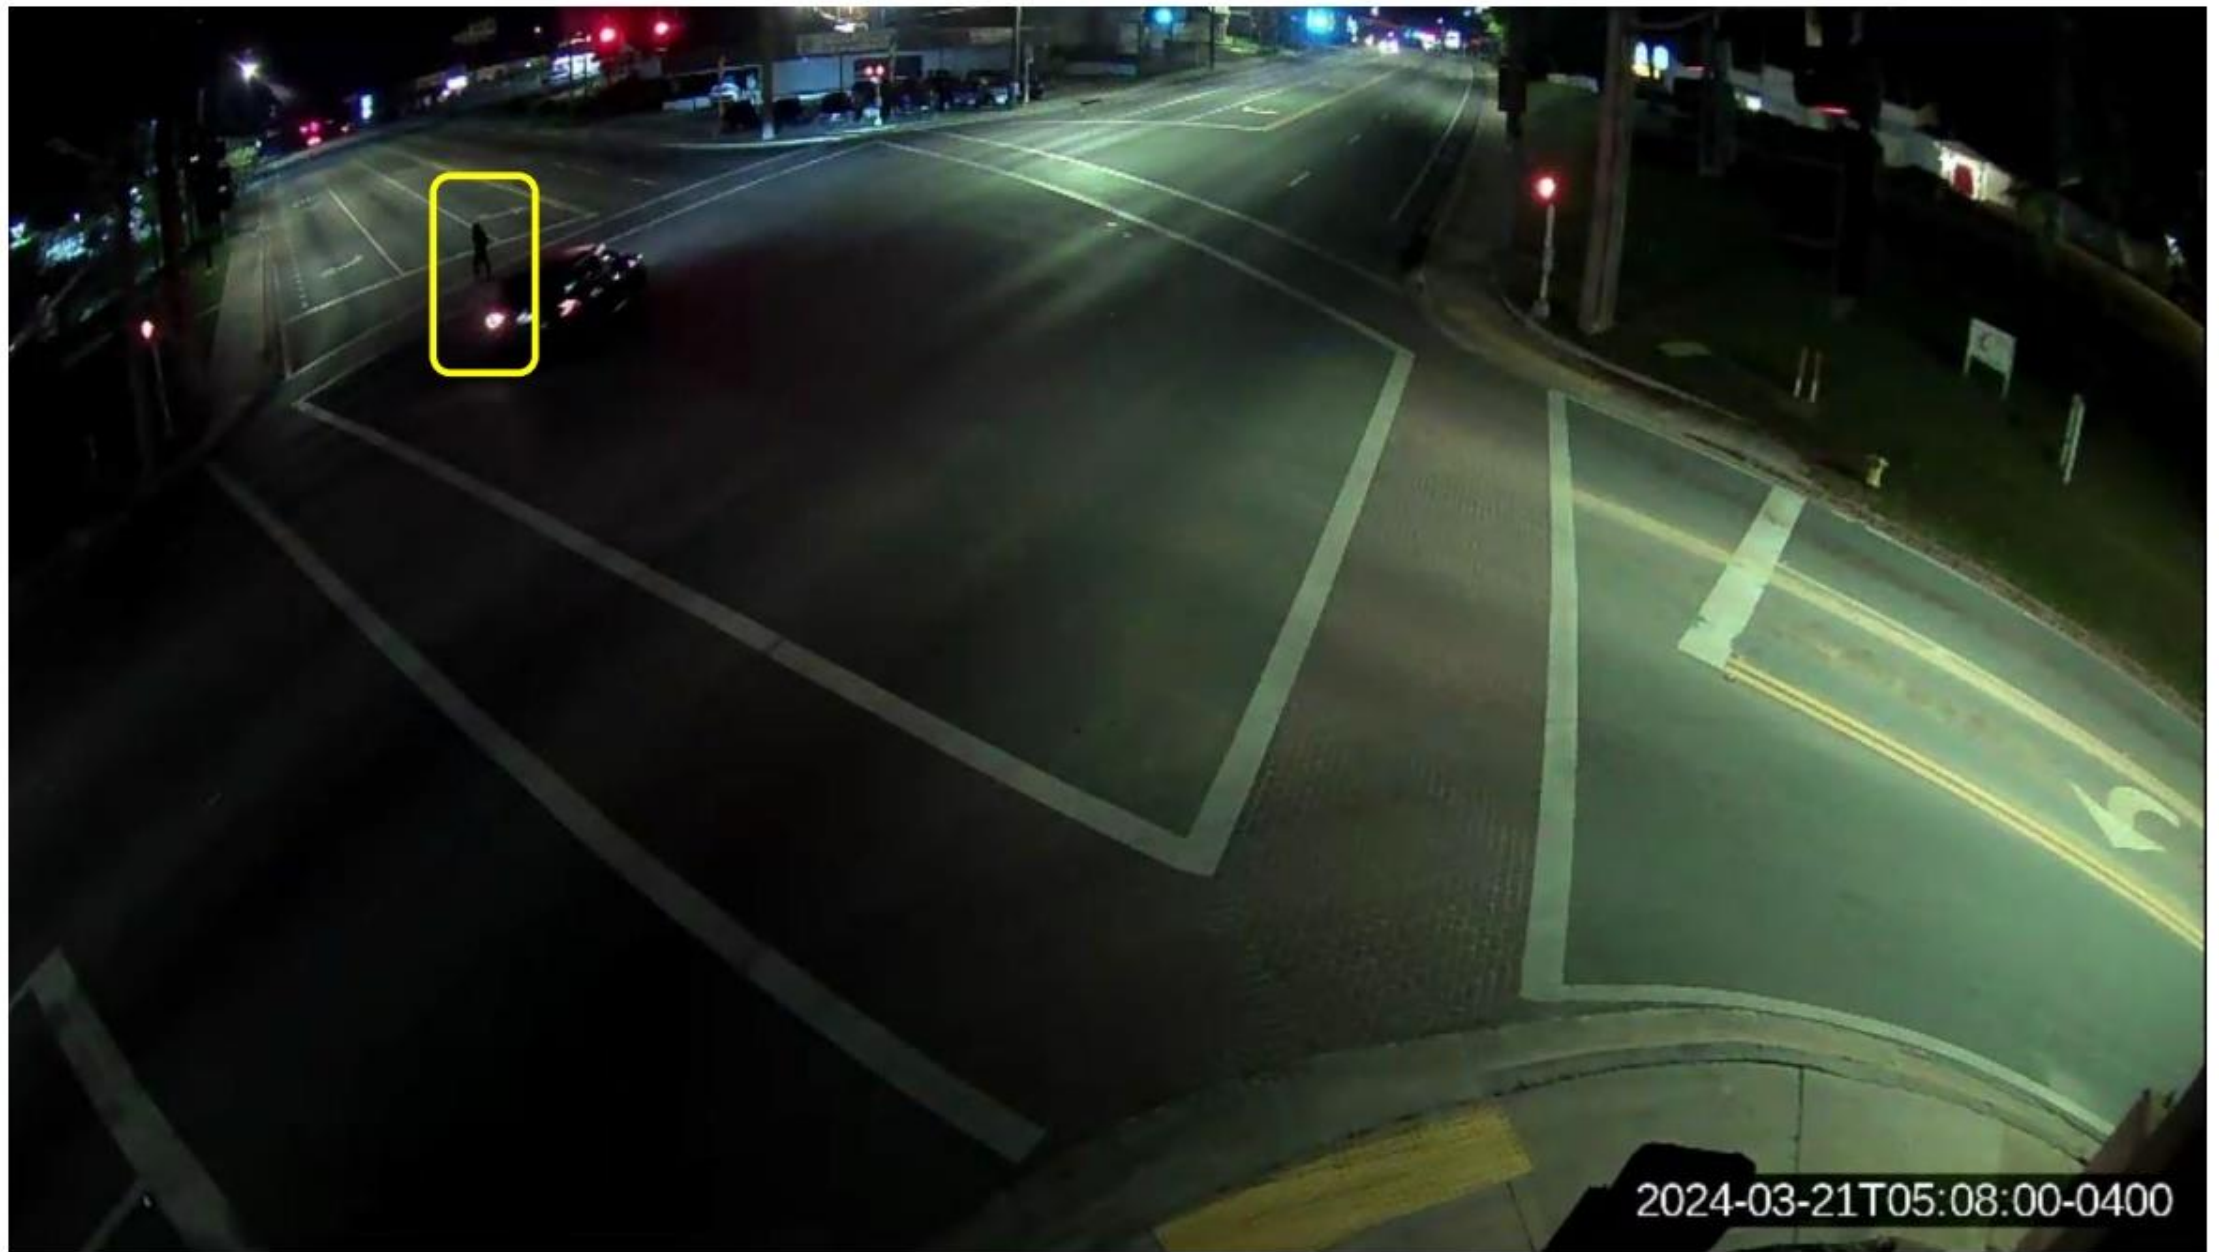
Figure 1: Pedestrian crossing west crosswalk and needs to stop due to vehicle performing a left turn in a low visibility environment. (Date 03/21/2024 at 05:08 AM)

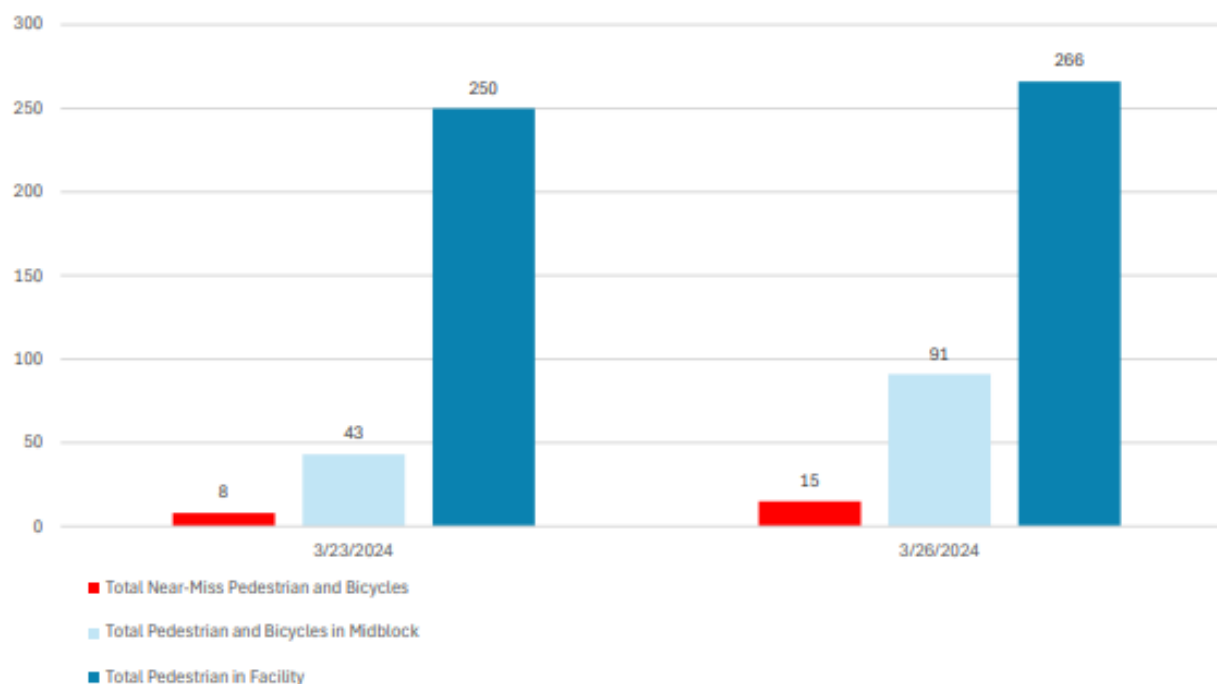
Total Volume of Pedestrians and Bicycles in Facility and Midblock Crossing

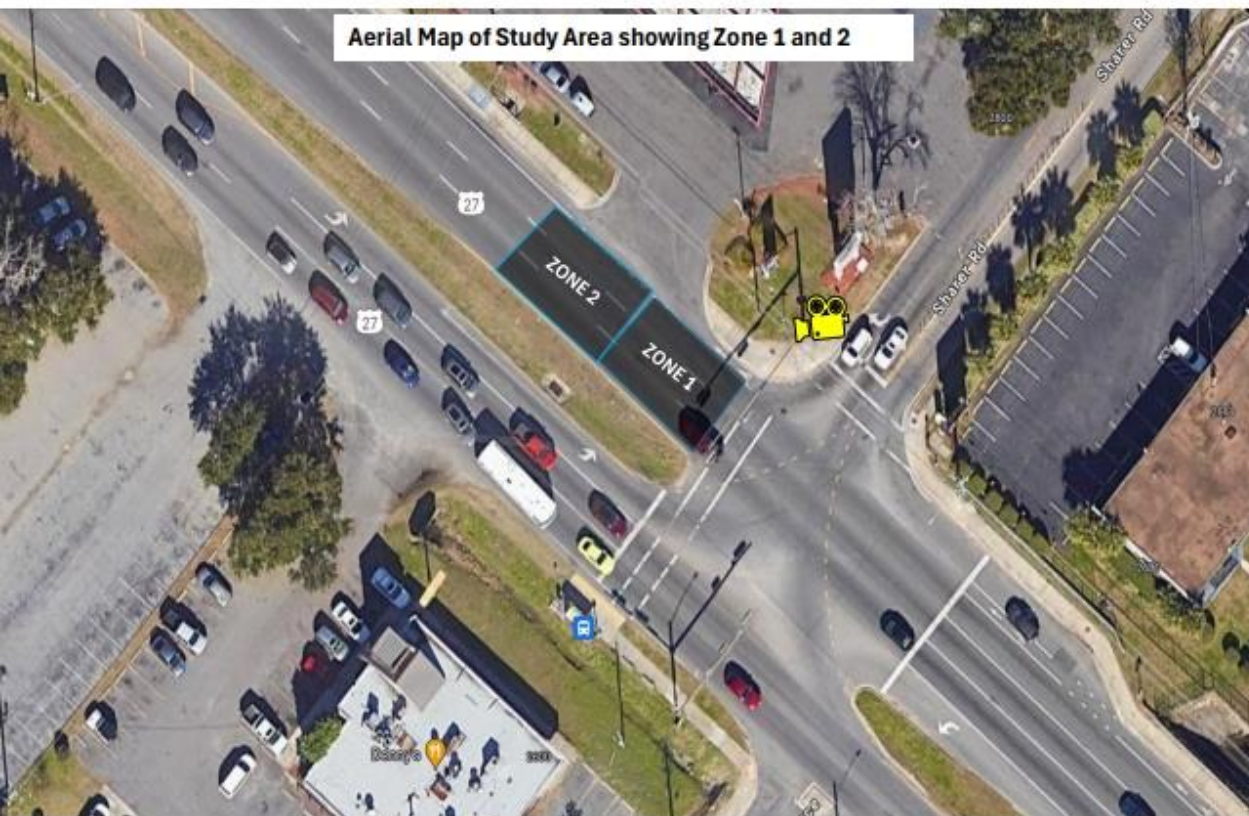
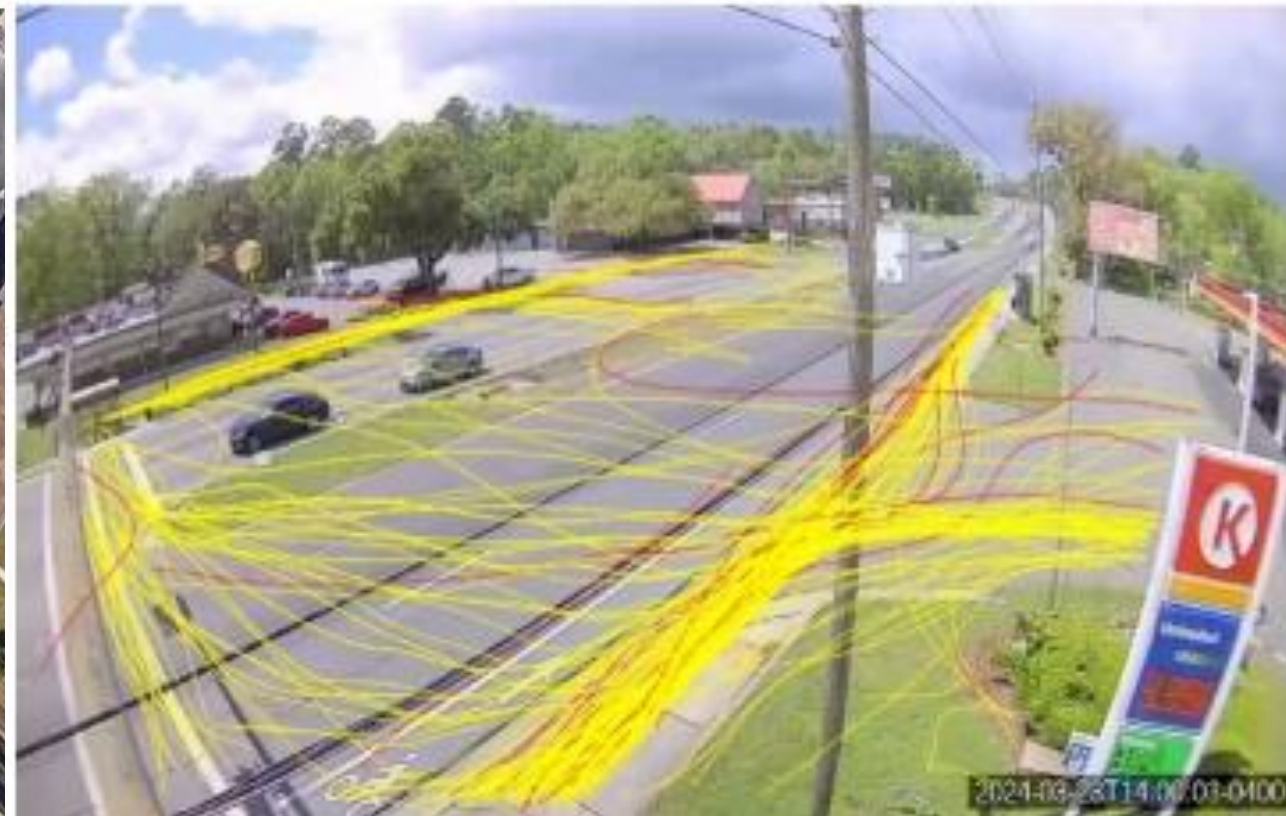
Average Near-Miss Time per Zone (in sec.)

Total Volume of Midblock Crossing with Near-Miss Events per Zone

Crossing Time per Direction (in sec.)

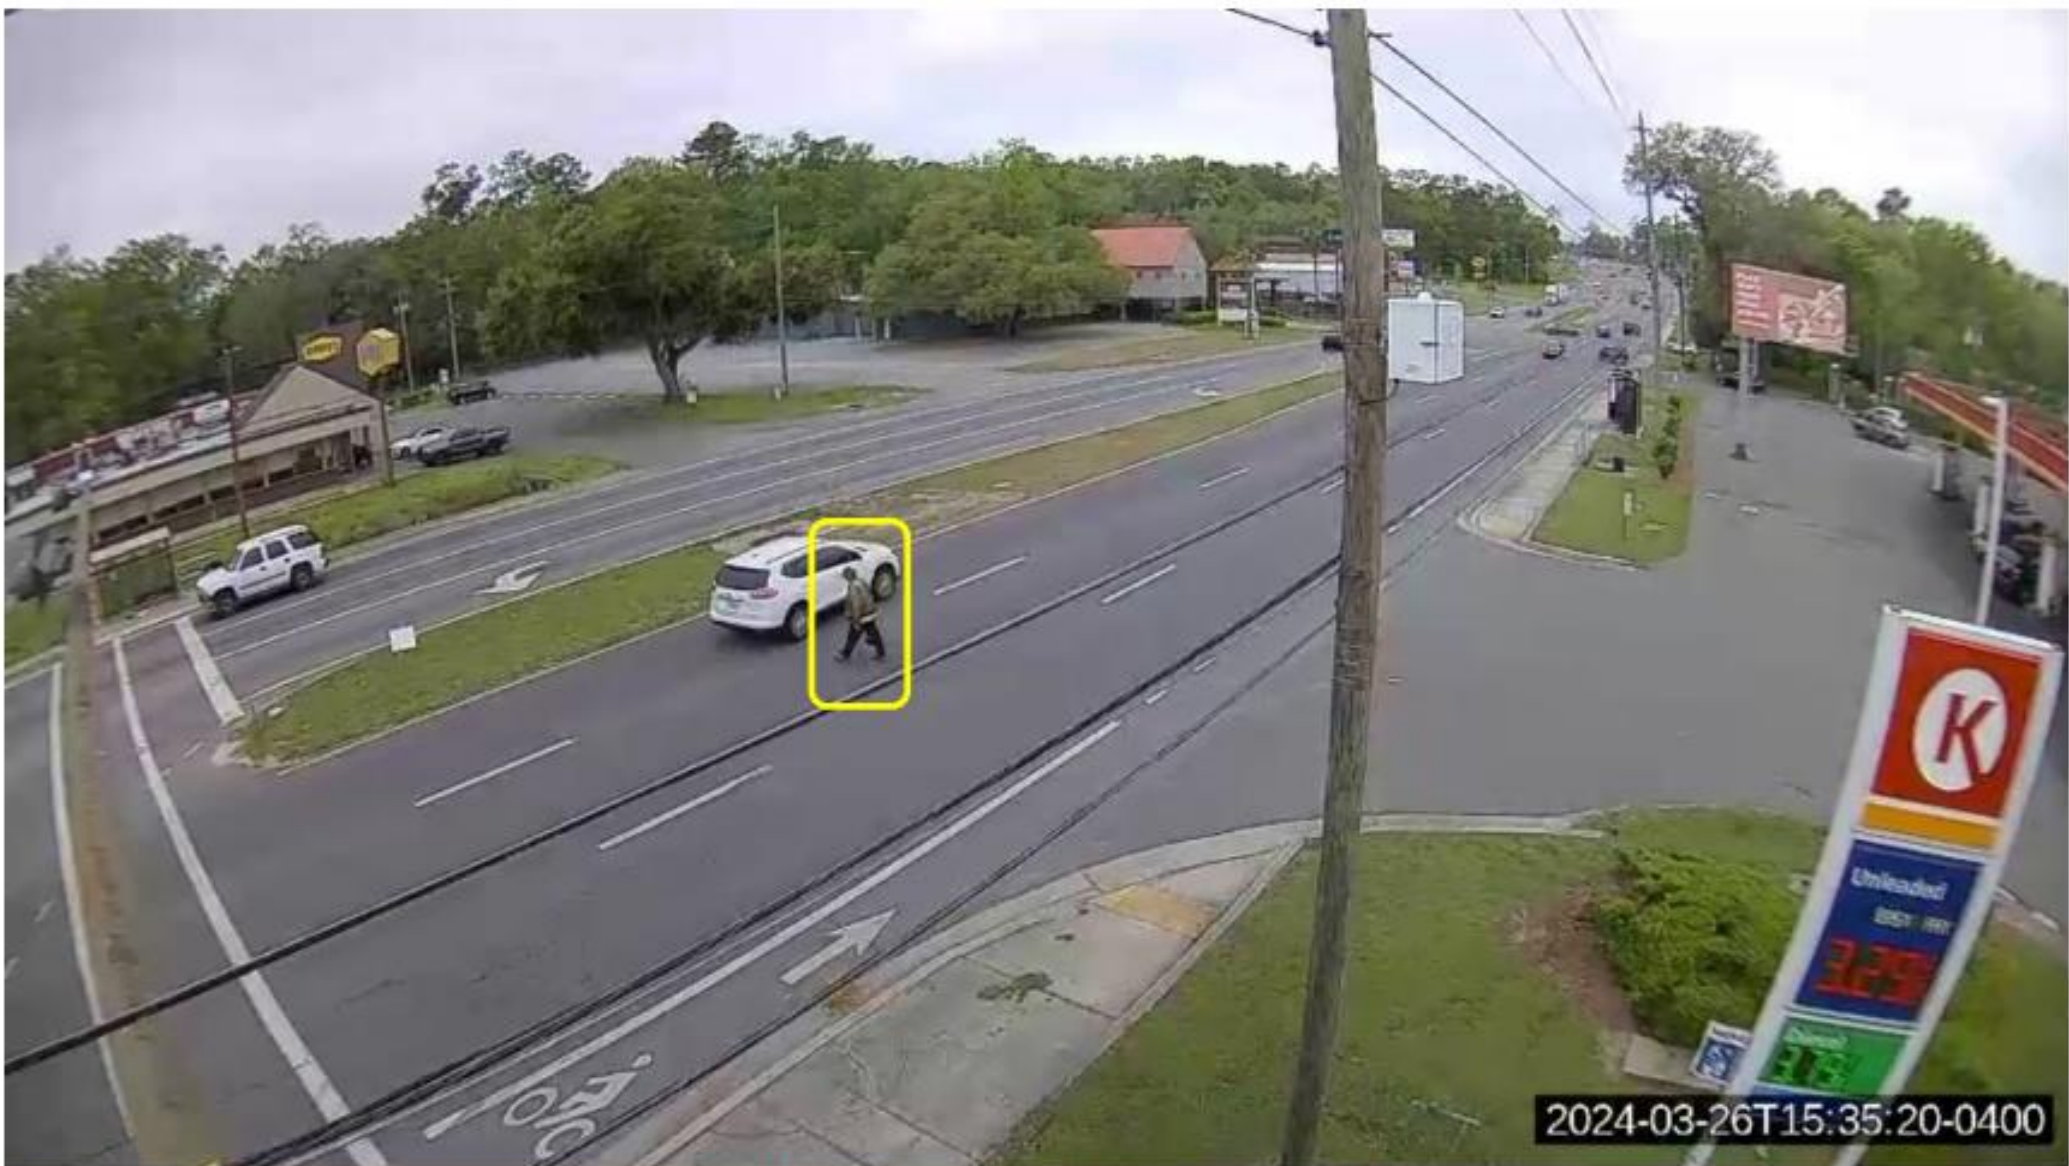
Figure 4: Pedestrian starts crossing westbound near the Gas Station driveway and passes near an incoming vehicle entering US Hwy 27 from the east leg of Sharer Rd. It represents a near-miss case where the driver had to evade the pedestrian. (Date 03/26/2024 at 3:35 PM)

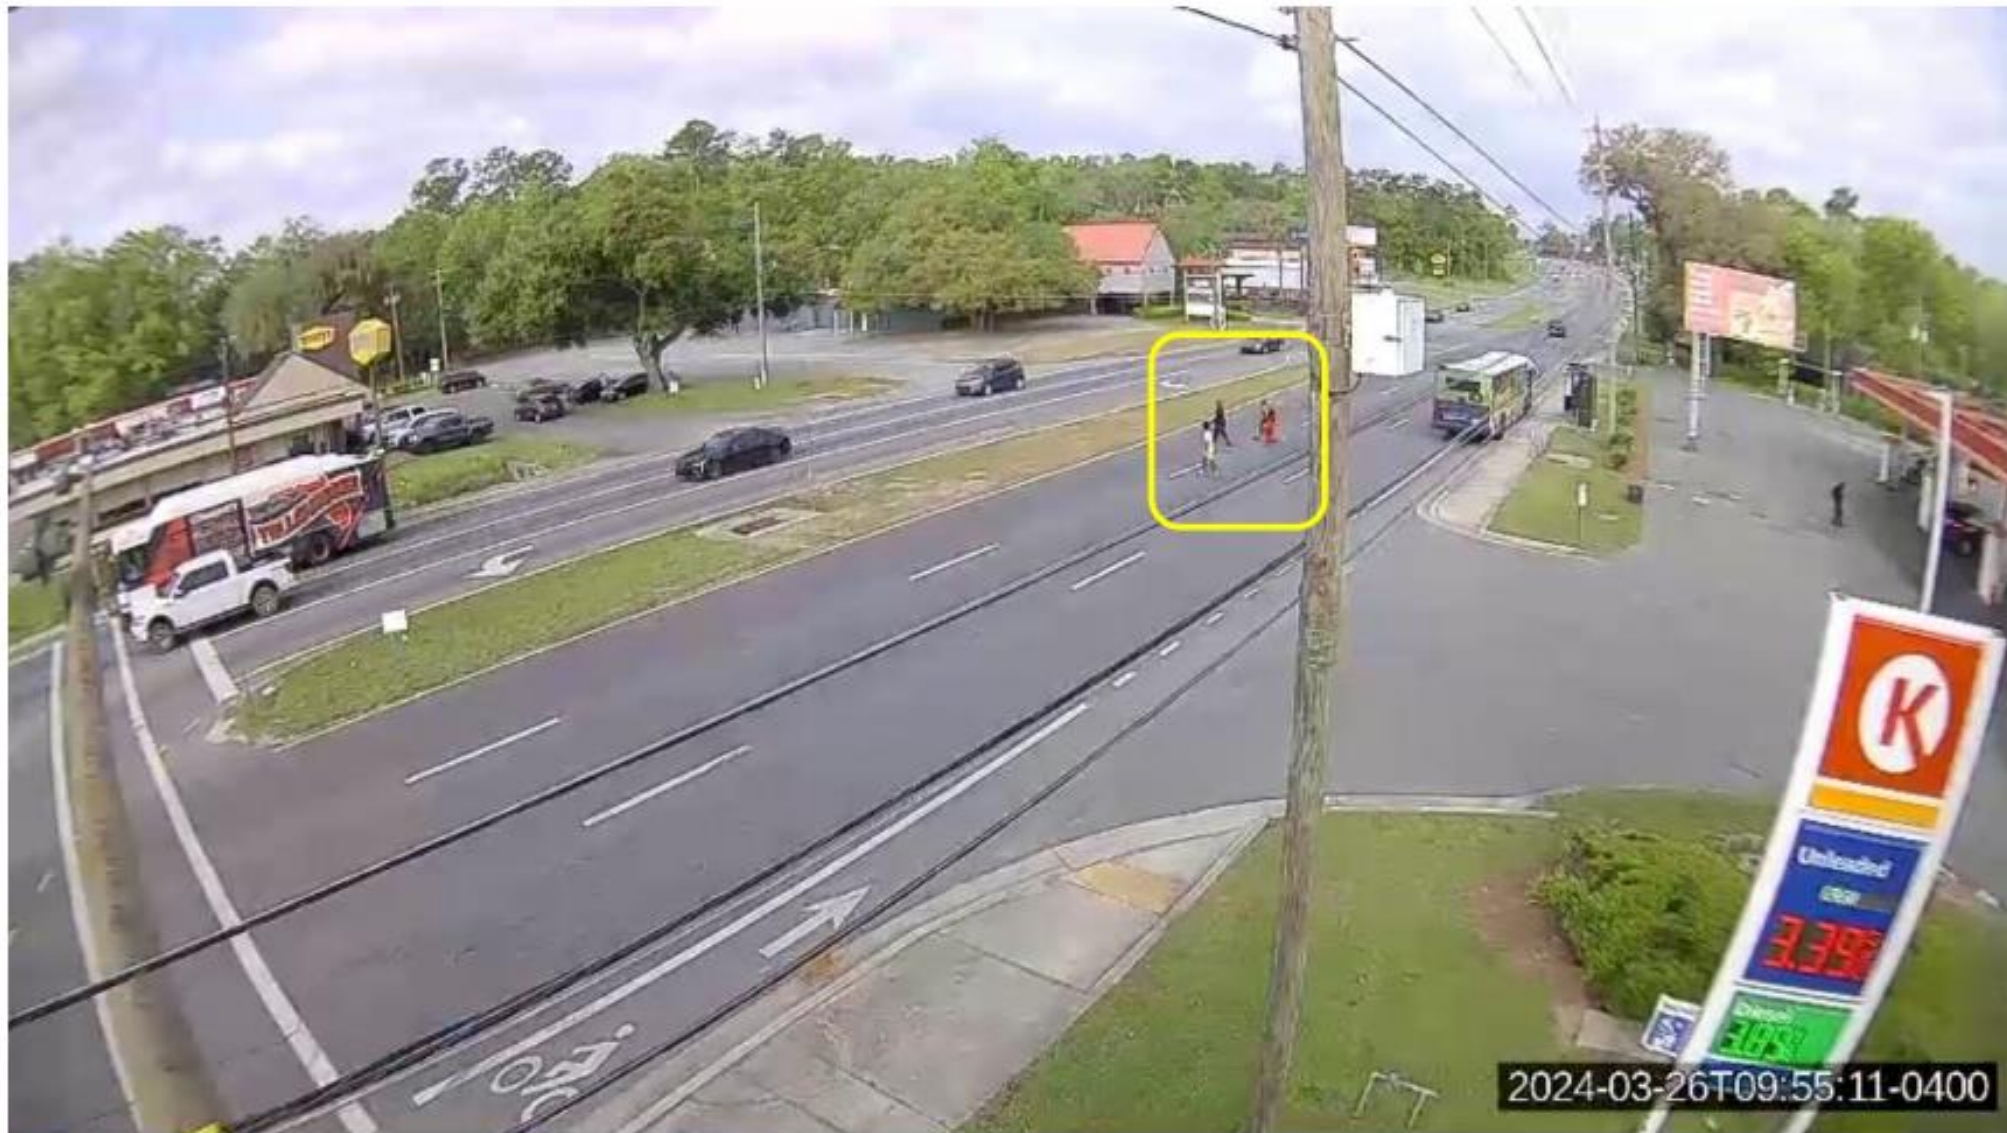
Figure 6: Four pedestrians depart the bus shown in the Bus Stop on the east sidewalk and perform a midblock crossing behind the bus and travel westbound into the median and west sidewalk with incoming traffic. (Date 03/26/2024 at 09:55 AM)
