# **C.R. 581 (BELLAMY BROTHERS BOULEVARD) FROM S.R. 52 TO HERNANDO COUNTY LINE RSA RECOMMENDATIONS**

Anthony Chaumont, PE, RSP1 - JMT  
March 25, 2026

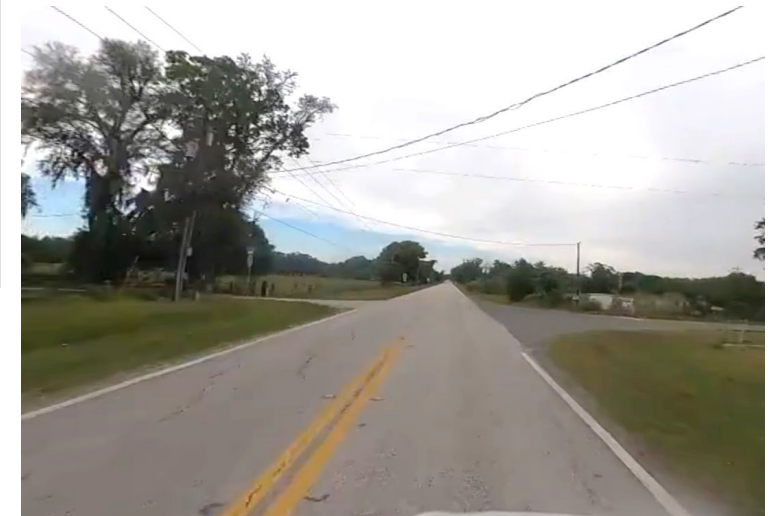
# INTERSECTION WARNING SIGNAGE

Miller Road, Darby Road, St. Joe Road, Bent Fork Road, Johnston Road, Bayhead Road

| Observation | Vehicles traveling EB and WB cause safety concerns at intersections for NB and SB movement |

| Recommendation | Add intersection warning signs at intersections where fatal/severe crashes occurred |

| <i>Action Taken</i> | <i>Date of Action</i> | <i>Implementation Mechanism</i> |
|--|---|---|
| Intersection warning signs were added for Darby Road and Bayhead Road near: (+28.359023°, -82.358096°), (+28.362346°, -82.358174°), (+28.422230°, -82.370719°), (+28.425360°, -82.370818°) | May – June 2023 | |

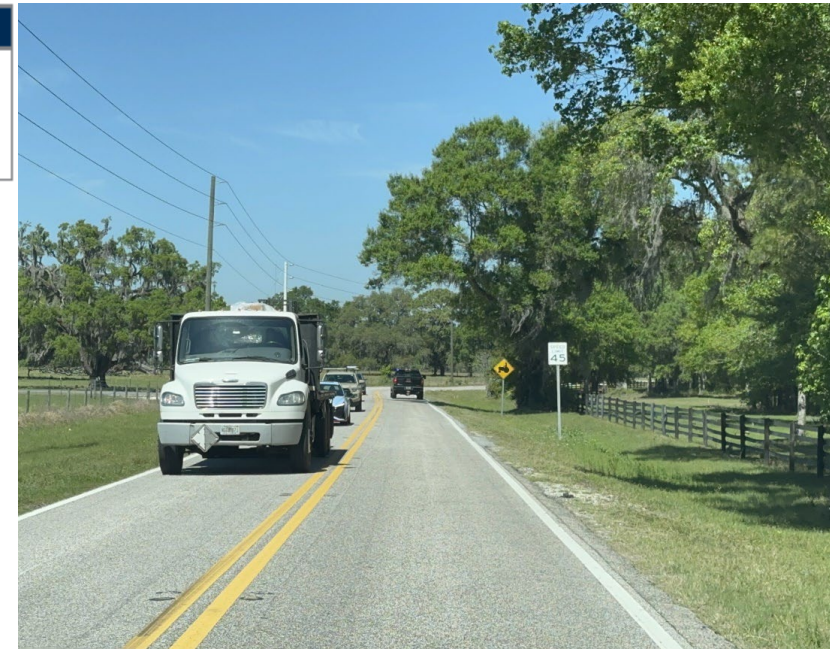
# TRUCK SIGNAGE

| Corridor Wide | |
|---|--|
| Observation | Trucks traveling NB and SB were observed to cause opposing vehicles to travel on the outside of the travel lane due to the width of the trucks |

| Corridor Wide | |
|---|--|
| Recommendation | Add signs restricting truck access (temporary solution) |

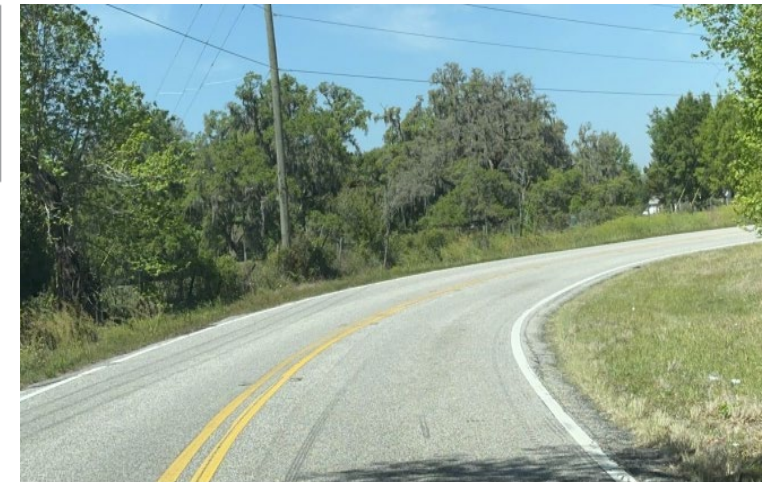
# NO SHOULDER WARNING SIGN

| Observation | Vehicles traveling NB and SB were observed to travel off-road while attempting to travel along the curves where there was no paved shoulder |

| Recommendation | Add a no shoulder warning sign at the beginning of the curves in the NB and SB directions (temporary solution) |

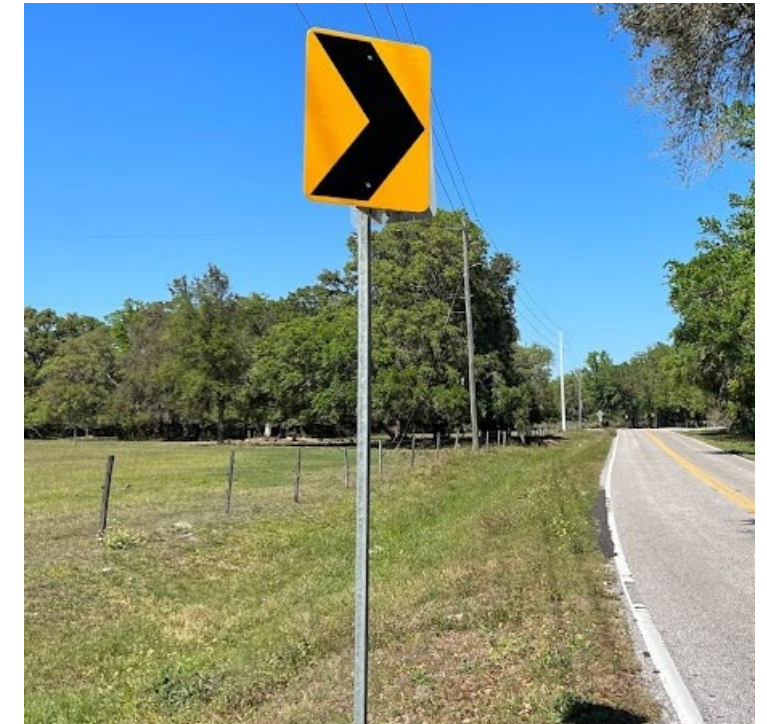
# REFLECTIVE WARNING SIGNAGE

| Corridor Wide | |
|---|---|
| Observation | Posted sign assemblies were observed to not include reflective strips |

| Corridor Wide | |
|---|---|
| Recommendation | Add reflective strips to all posted signs |

| <i>Action Taken</i> | <i>Date of Action</i> | <i>Implementation Mechanism</i> |
|--|---|---|
| Reflective post strips were added by Pasco County. | May – June 2023 | |

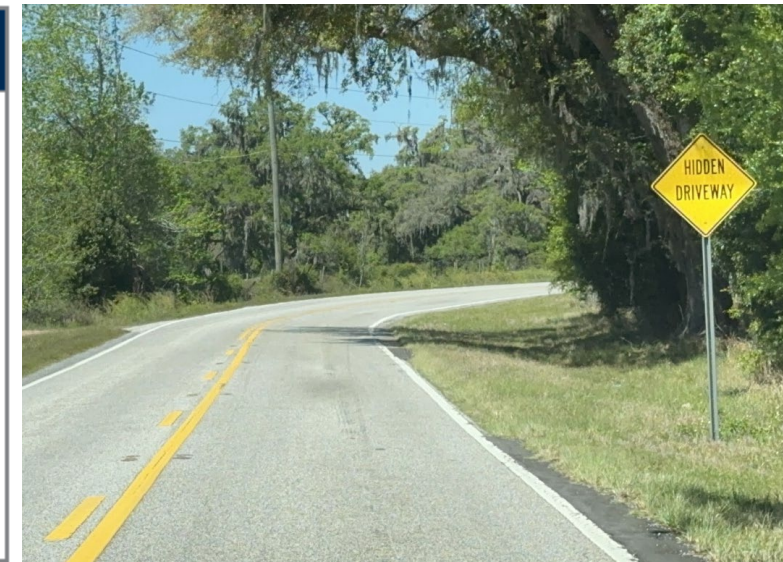
# POSITIVE GUIDANCE SIGNAGE

| Corridor Wide | |
|---|--|
| Observation | Corridor lacked signage guiding drivers |

| Corridor Wide | |
|---|--|
| Recommendation | Add positive guidance signage along the corridor to inform drivers of upcoming conditions including, but not limited to, hidden driveway signs, advance street name signs, intersection ahead signs, curve ahead signs, advisory speed limit signs |

| Action Taken | Date of Action | Implementation Mechanism |
|--|---|---|
| Additional curve and intersection warning signs were added by Pasco County near: (+28.392427°, -82.371139°), (+28.403421°, -82.370520°), (+28.404616°, -82.370496°), (+28.407227°, -82.371492°), (+28.412665°, -82.370701°), (+28.407517°, -82.371580°), (+28.406905°, -82.371482°), (+28.406702°, -82.371439°), (+28.406477°, -82.371324°), (+28.406454°, -82.371393°), (+28.393295°, -82.371179°), (+28.392974°, -82.371209°), (+28.392643°, -82.371122°), (+28.392364°, -82.371006°), (+28.385653°, -82.364163°), (+28.377337°, -82.362247°), (+28.326679°, -82.357958°), (+28.359023°, -82.358096°), (+28.362346°, -82.358174°), (+28.422230°, -82.370719°) (+28.425360°, -82.370818°) | May – June 2023 | |

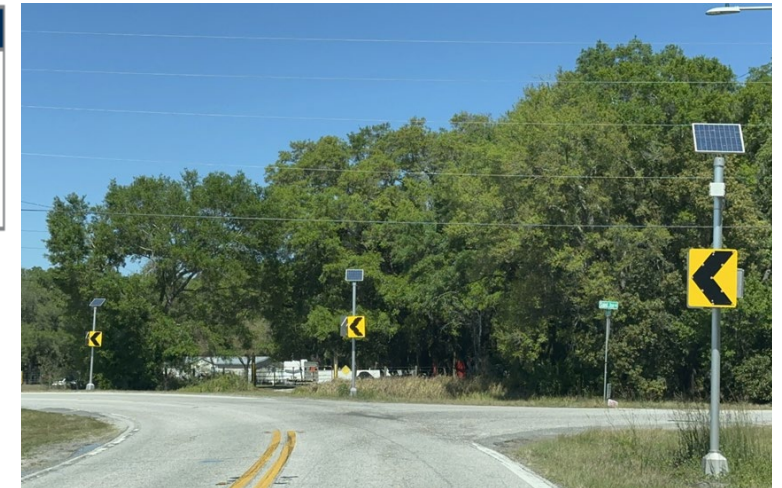
# RAISED PAVEMENT MARKERS (RPMs) ON EDGELINES

| Various Curves | |
|---|---|
| Observation | Curves do not provide RPMs along the edgeline |

| Various Curves | |
|---|---|
| Recommendation | Add RPMs along the edgelines of the curves where fatalities have occurred |

| <i>Action Taken</i> | <i>Date of Action</i> | <i>Implementation Mechanism</i> |
|--|---|---|
| Temporary tape and RPMs are being investigated for short-term improvement. | February 2024 | |

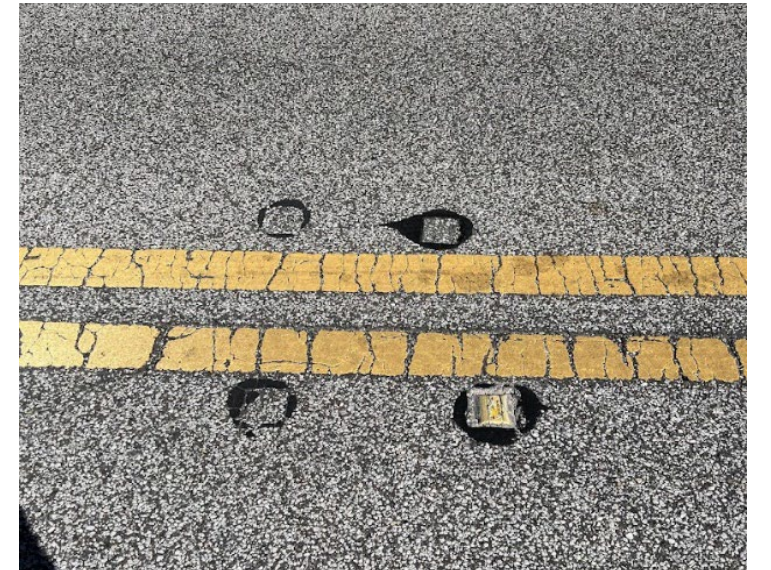
# RAISED PAVEMENT MARKERS (RPMs)

| Corridor Wide | |
|---|---|
| Observation | RPMs along the centerline have been removed due to vehicles driving over them |

| Corridor Wide | |
|---|---|
| Recommendation | Install new RPMs at a 10-foot center-to-center spacing along the centerline and edgeline striping between the PT and PC of each curve, and at a 40-foot spacing in the tangent sections |

| <i>Action Taken</i> | <i>Date of Action</i> | <i>Implementation Mechanism</i> |
|--|---|---|
| Temporary tape and RPMs are being investigated for short-term improvement. | February 2024 | |

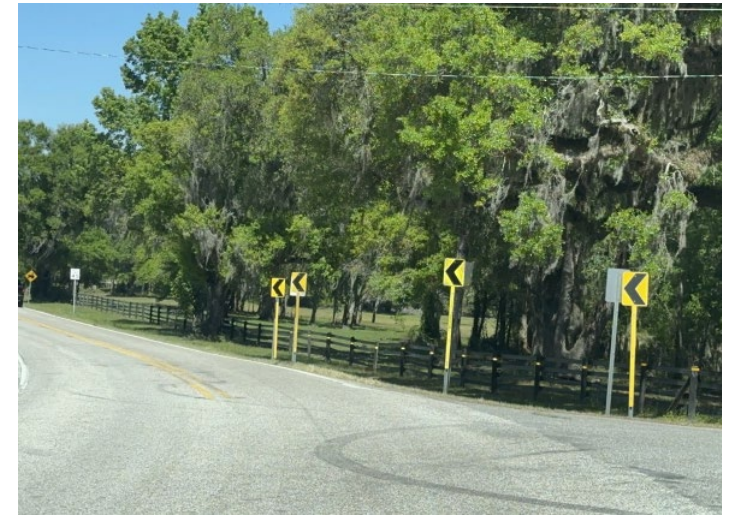
# REPOSITION CHEVRON SIGNS

| Observation | Existing chevrons signs were observed to not cover full length of the curve from start to end |

| Recommendation | Reposition existing chevron signs and add additional signs if needed to start and end through the full curve with evenly spaced signs |

| <i>Action Taken</i> | <i>Date of Action</i> | <i>Implementation Mechanism</i> |
|---|---|---|
| Chevron signs were added and repositioned along the curves by Pasco County. | May – June 2023 | |

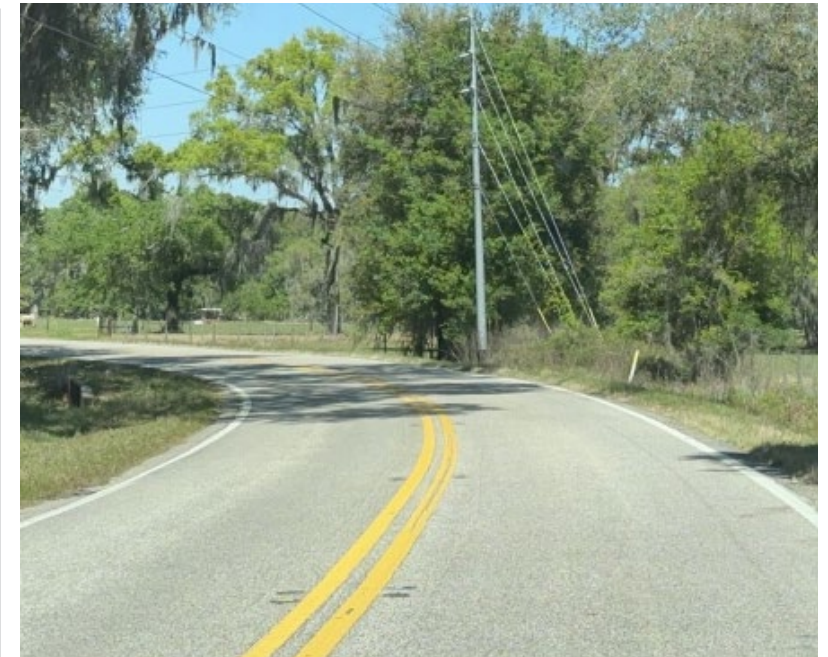
# CURVE WARNING AND CHEVRON SIGNAGE

| Corridor Wide | |
|---|---|
| Observation | Multiple curves were observed to be without curve warning and chevron signs |

| Corridor Wide | |
|---|---|
| Recommendation | Add curve warning and chevron signs at the missing curves along the segment |

| Action Taken | Date of Action | Implementation Mechanism |
|---|---|---|
| Additional curve warning signs and chevrons were added by Pasco County near: (+28.392427°, -82.371139°), (+28.403421°, -82.370520°), (+28.404616°, -82.370496°), (+28.407227°, -82.371492°), (+28.412665°, -82.370701°), (+28.407517°, -82.371580°), (+28.406905°, -82.371482°), (+28.406702°, -82.371439°), (+28.406477°, -82.371324°), (+28.406454°, -82.371393°), (+28.393295°, -82.371179°), (+28.392974°, -82.371209°), (+28.392643°, -82.371122°), (+28.392364°, -82.371006°), (+28.385653°, -82.364163°), (+28.377337°, -82.362247°), (+28.326679°, -82.357958°), (+28.359023°, -82.358096°), (+28.362346°, -82.358174°), (+28.422230°, -82.370719°), (+28.425360°, -82.370818°) | May – June 2023 | |

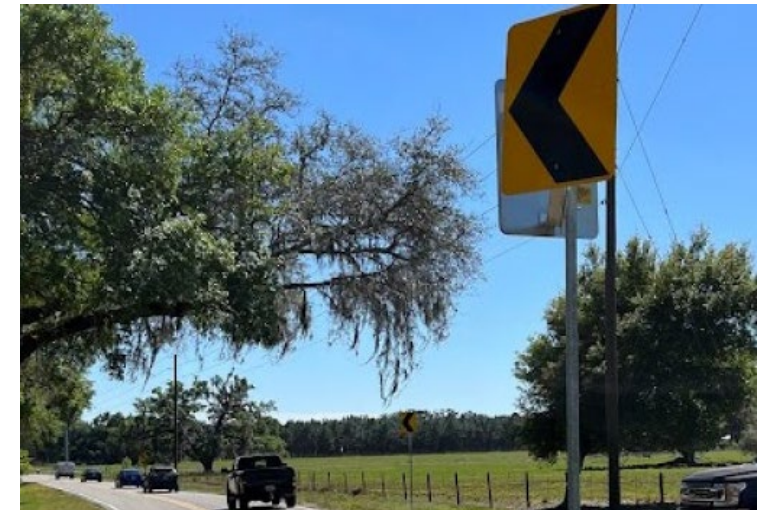
# CHEVRON SIGN GEOMETRY

| Corridor Wide | |
|---|--|
| Observation | Existing chevron signs were observed to differ from the geometry of the curve; the chevrons were turned or not facing down the direction of the curve |

| Corridor Wide | |
|---|--|
| Recommendation | Conduct a full review of the existing chevron signs to confirm they complement the geometry of the curve, and provide an educational opportunity for the signage installers on how to properly angle the chevron signs |

| <i>Action Taken</i> | <i>Date of Action</i> | <i>Implementation Mechanism</i> |
|---|---|---|
| Chevron signs were added and repositioned along the curves by Pasco County. | May – June 2023 | |

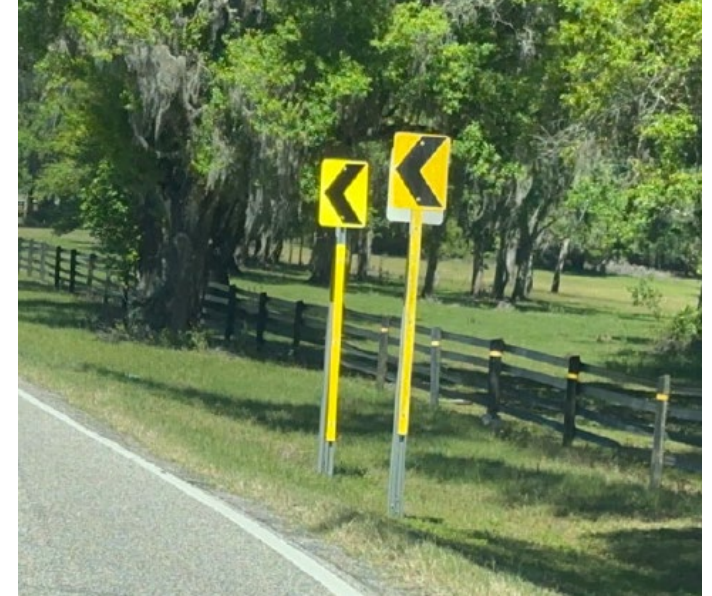
# CHEVRON SIGN SIZE

| Corridor Wide | |
|---|---|
| Observation | Existing chevron signs size were observed not to be up to standard |

| Corridor Wide | |
|---|---|
| Recommendation | Conduct a full review of the existing chevron signs to confirm the size of the signs are up to standard per MUTCD 2C.04 |

| <i>Action Taken</i> | <i>Date of Action</i> | <i>Implementation Mechanism</i> |
|--|---|---|
| Chevron signs along the curves were measured and sizes were confirmed by Pasco County. | May – June 2023 | |

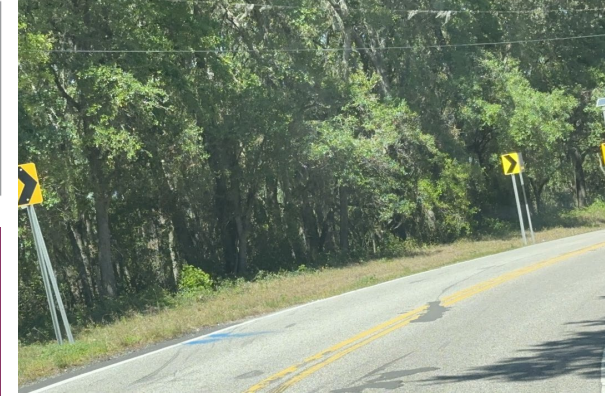
# DYNAMIC LED CURVE SIGNAGE

| Corridor Wide | |
|---|--|
| Observation | Curves with fatal/severe injury crash history were observed to have chevron signs without dynamic LED curve signage system |

St. Joe Road curve has LED chevrons  
 Bent Fork Road curve has leading LED chevrons  
 Johnston Road curves do not have any LED curve signage (already existing at time of study; installed 2019)

| Corridor Wide | |
|---|--|
| Recommendation | Replace the existing chevron signs with a dynamic LED curve signage system. |

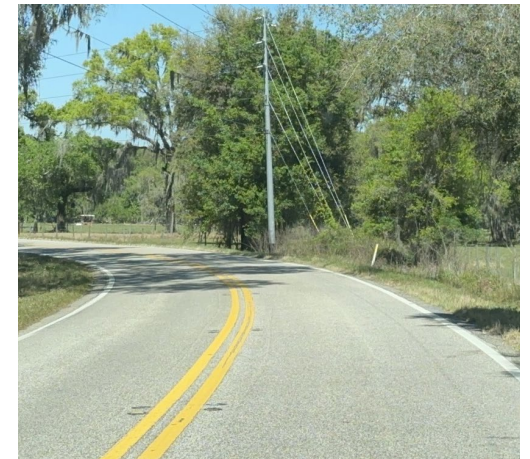
# REFLECTIVE MATERIAL

## Curve near Snowcat Ridge

| Observation | Existing utility pole was observed to be without reflectivity |

| Recommendation | Add an object marker and reflective material to the pole |

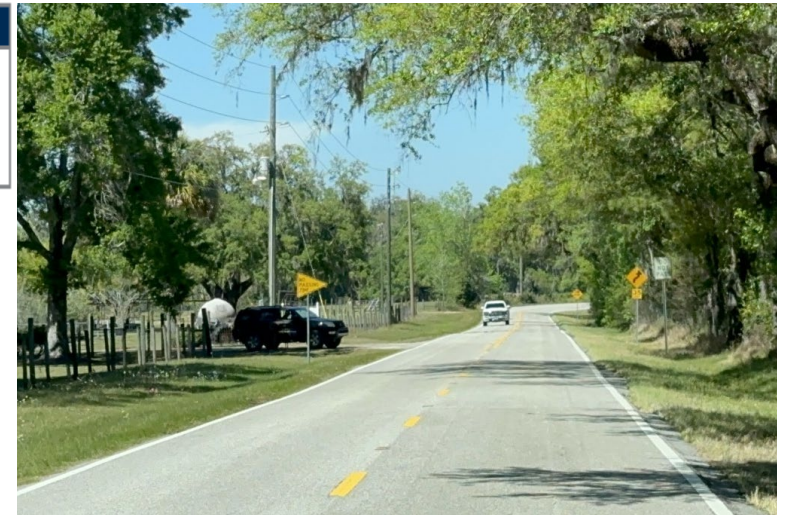
# NO PASSING

| Corridor Wide | |
|---|--|
| Observation | Vehicles were observed passing one another while having their view obstructing from oncoming traffic from other directions |

| Corridor Wide | |
|---|--|
| Recommendation | Conduct a no passing zone study and add double yellow lines |

| <i>Action Taken</i> | <i>Date of Action</i> | <i>Implementation Mechanism</i> |
|---|---|---|
| The study is currently being conducted by Pasco County. | February 2024 | |

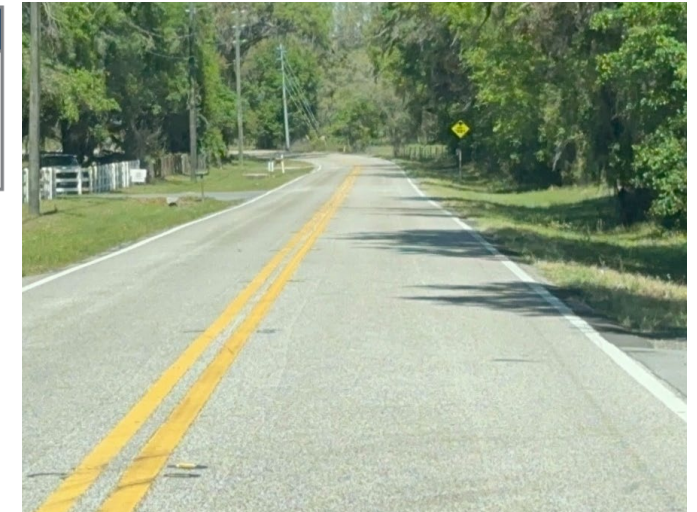
# CURVE AHEAD STUDY

| Corridor Wide | |
|---|---|
| Observation | The segment was observed to lack pavement messages warning drivers of oncoming curves |

| Corridor Wide | |
|---|---|
| Recommendation | Conduct a curve ahead pavement message study |

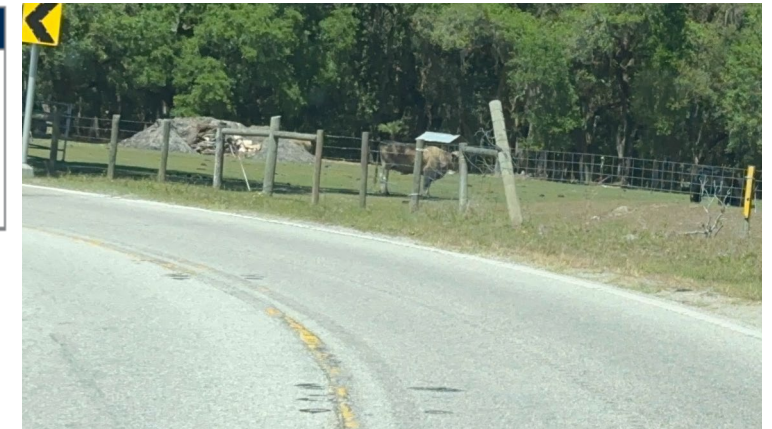
# RESTRIPING

| Corridor Wide | |
|---|--|
| Observation | The pavement striping condition was observed to be in poor condition; this could be a contributing factor in the high number of run-off-road crashes |

| Corridor Wide | |
|---|--|
| Recommendation | Restripe the pavement along the centerline and edgelines along the corridor |

| Action Taken | Date of Action | Implementation Mechanism |
|--|---|---|
| Temporary tape and RPMs are being investigated for short-term improvement. | February 2024 | |

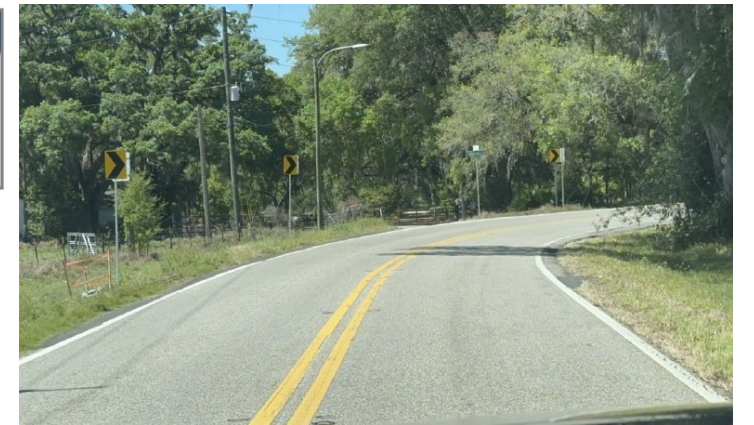
# HIGH FRICTION SURFACE TREATMENT

| Corridor Wide | |
|---|---|
| Observation | The pavement condition was observed to be in poor condition |

| Corridor Wide | |
|---|---|
| Recommendation | Install a high friction surface treatment along the radius of each curve along the corridor |

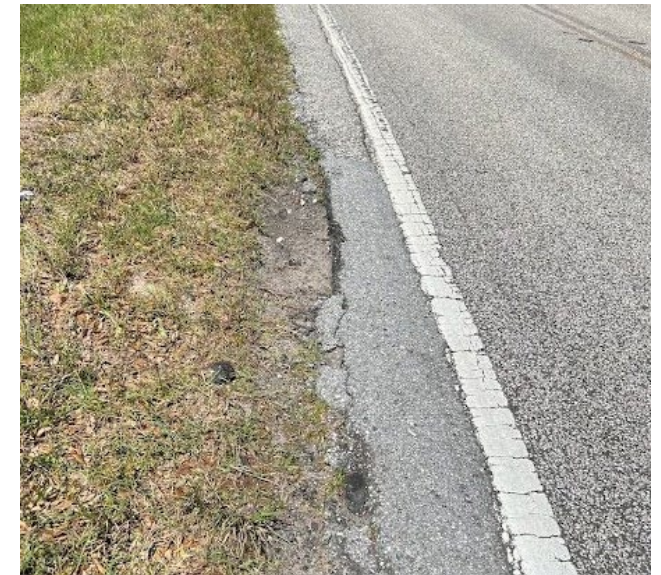
# PAVEMENT DETERIORATION

| Corridor Wide | |
|---|---|
| Observation | The shoulder along the corridor was observed to be deteriorating causing vehicles to cut into the yellow median lines to avoid the dips |

| Corridor Wide | |
|---|---|
| Recommendation | Widen the pavement, add a safety edge, and add centerline rumble strips |

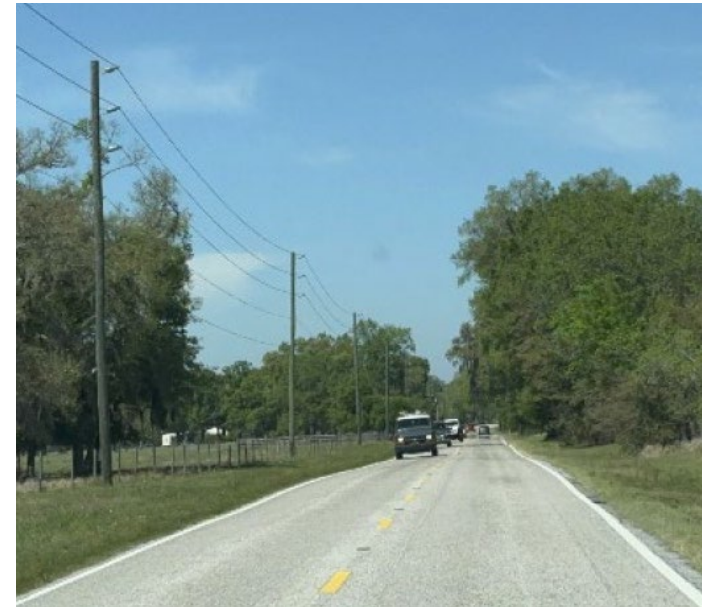
# LIGHTING

## Bayhead Road, Johnston Road, Henlon Terrace

| Observation | Lighting was not present in several areas of the segment |

| Recommendation | Coordinate with the utility company to install luminaires along segments with existing utility poles |
