High Friction Surface Treatments

-Florida Practices and Safety Performance Analysis

Guangming Wang, Ph.D, P.E.

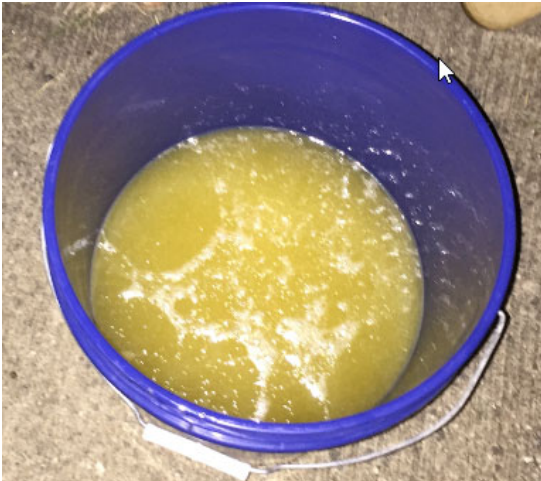
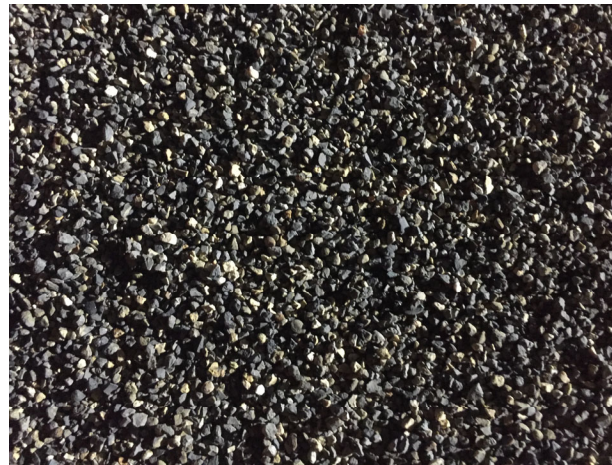
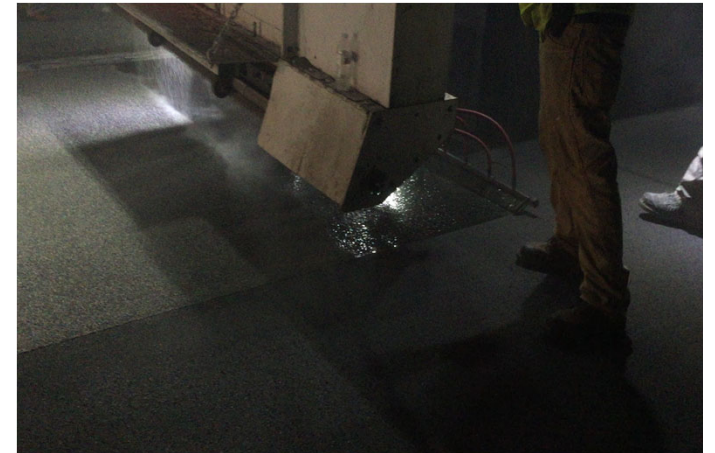
What is a High Friction Surface Treatment (HFST)?

- High-quality, polish-resistant aggregates + polymer resin binder.
- Most HFSTs were applied on curves/ramps where require higher friction demand.
- FHWA EDC innovation
- Estimated service life is 7-10 years

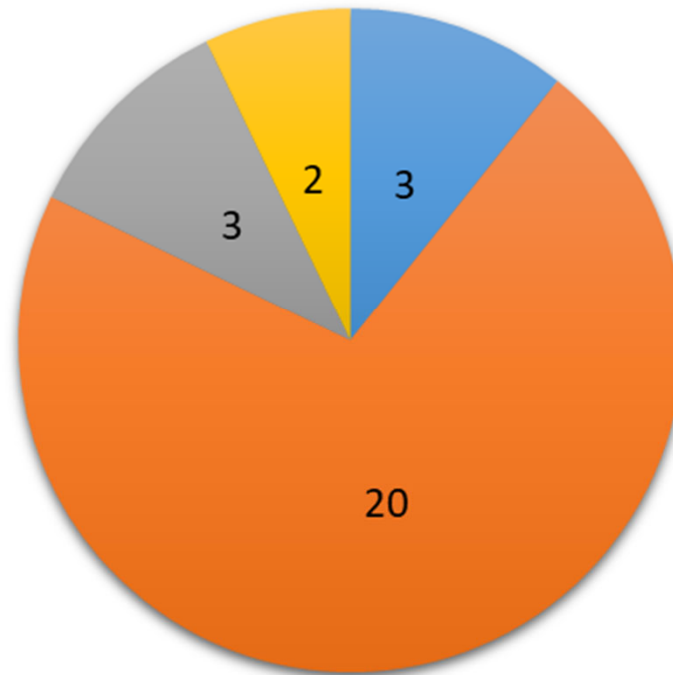
Summary of Florida HFST Mainline Projects
(2006-2019)

■ Curve ■ Ramp ■ Tangent ■ Intersection

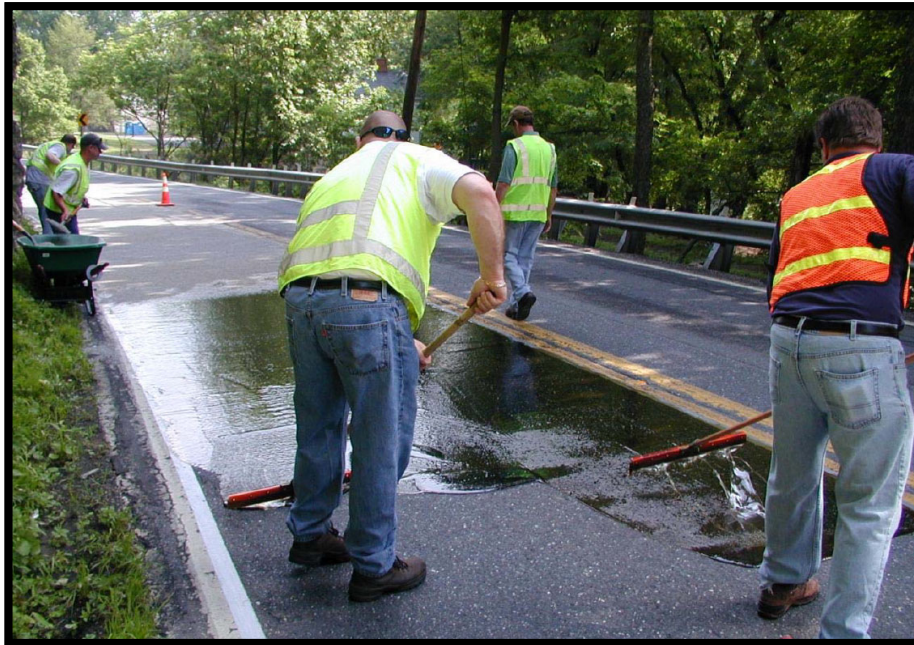
Manual Application – No longer acceptable

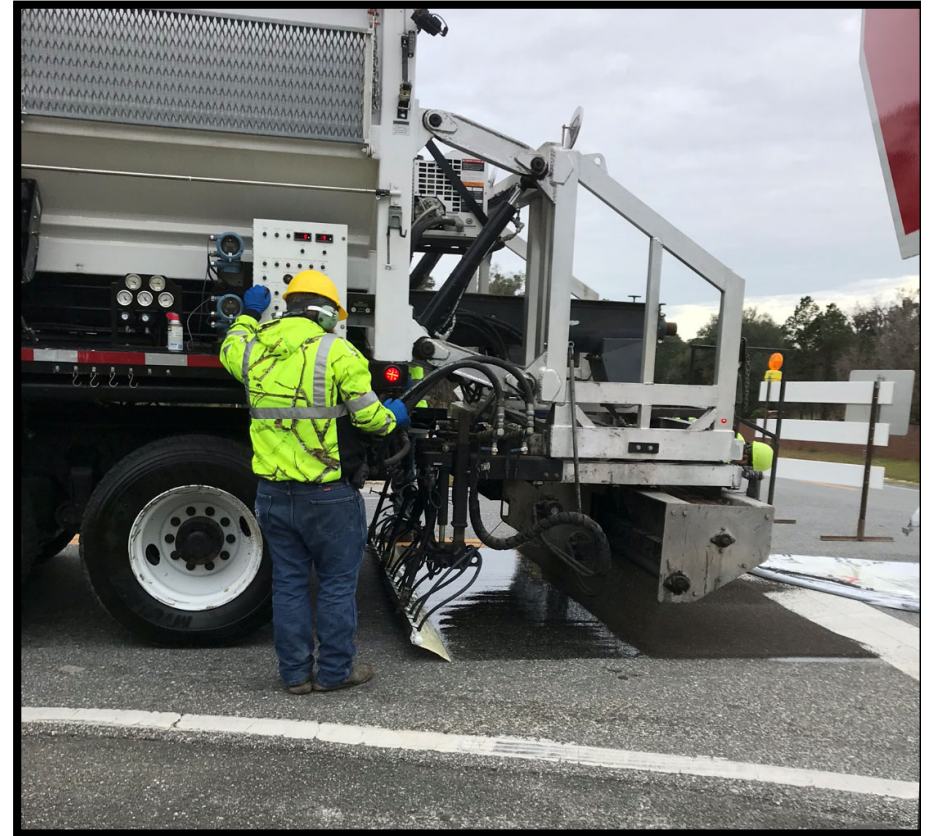
Automated Application – Now required for enhanced consistency and longevity

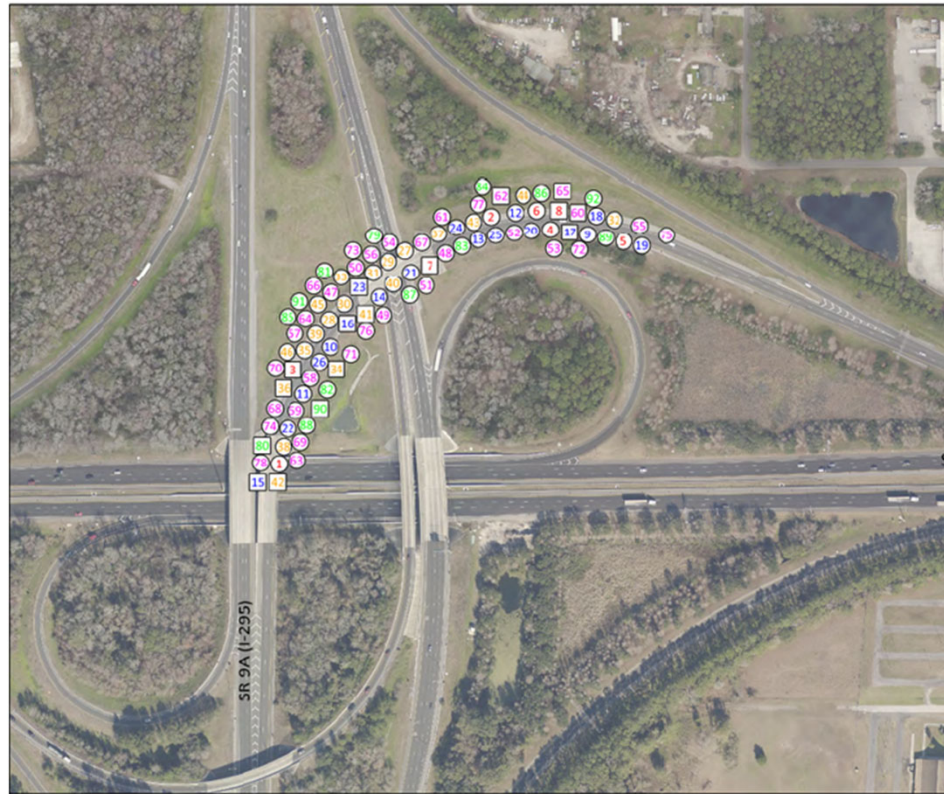
- Crash Diagram
 - Last 3/5-year crash events
 - Wet vs dry crashes
 - Roadway departure crashes

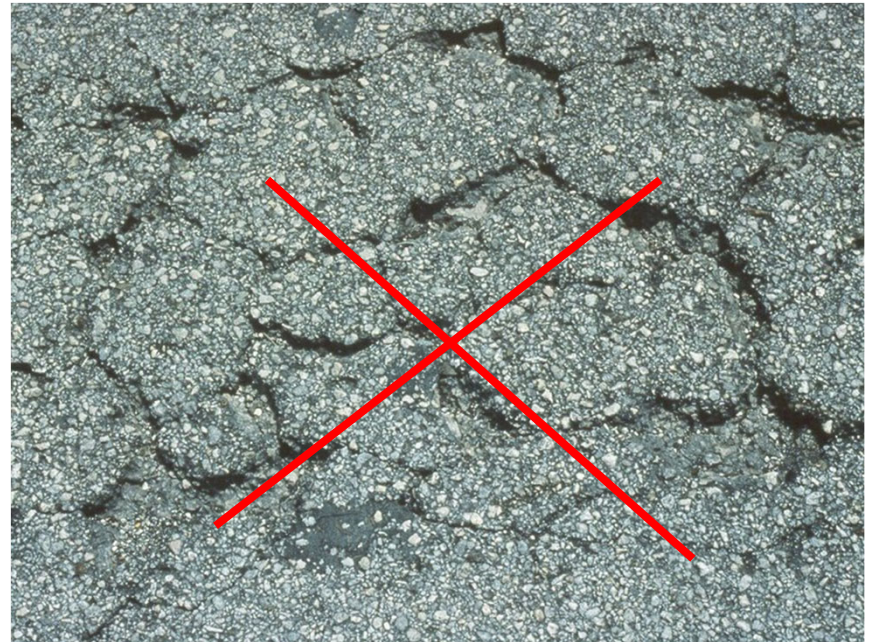
Pavement Condition Report

- Pavement Condition Evaluation
 - DGAC or Concrete
 - Overall Rating of “Good” and Higher
 - Rutting ≤ 0.25 ”
 - No structural damage
 - $\leq 6\%$ cracks

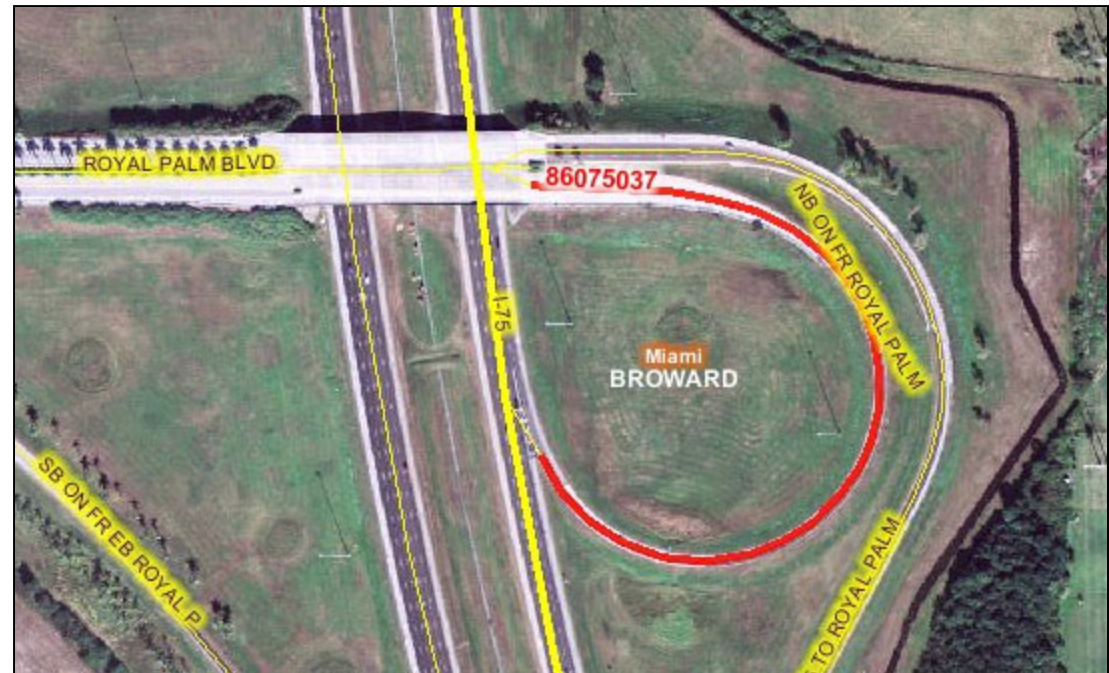
Royal Palm Boulevard/I-75 NB Ramp-2006 (Cont.)

- Built in 2006
- Still in Service (13 yrs)
- High FN
- Yearly crash rate reduced 45%
- Safety reported reduced driving speed

- A ramp to north I-75 in District 4 was treated with HFST in 2006 and still performs well with more than 60 of FN.

Friction Number (FN)		
Northbound Ramp		Test Date
Lane 1	Material	
35	Asphalt (FC-2)	4/11/2006
104	HFST	5/23/2006
66	HFST	3/8/2010
67	HFST	11/8/2013
68	HFST	12/6/2016

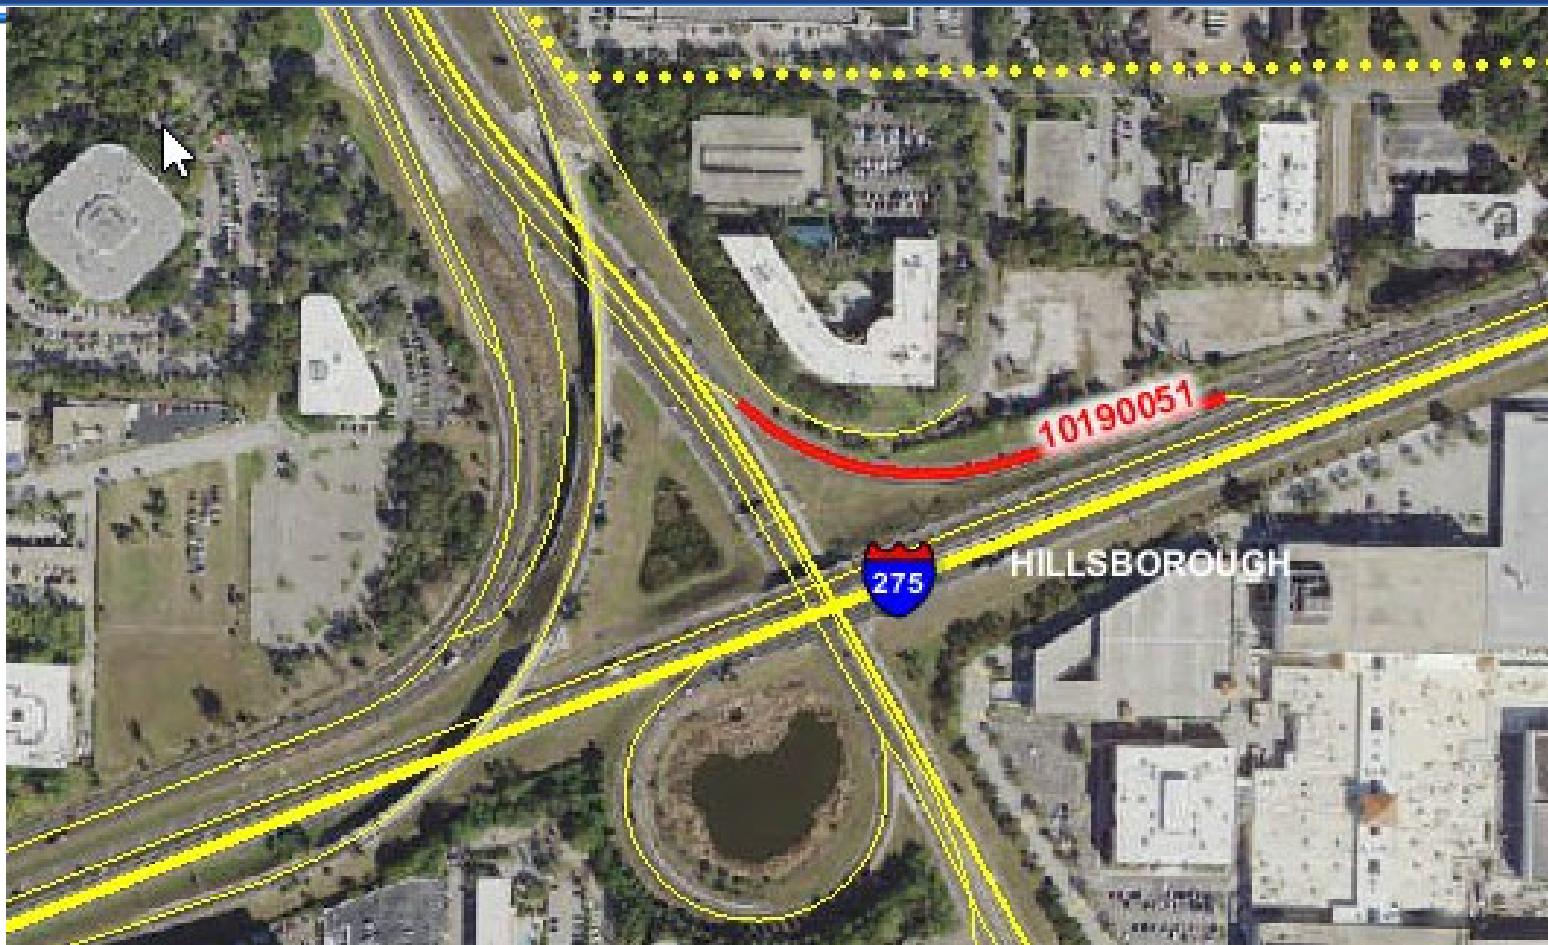
I-275 Southbound Off-Ramp at Memorial Highway to TIA

Number of Crashes			
Crash Type	Before HFST	First HFST Treatment	Second HFST Treatment
	(1/1/2010 to 10/31/2012)	(12/1/2012 to 9/30/2015)	(11/1/2015 to 6/30/2017)
wet	50	5	2
Off Roadway	6	2	1
Total Crashes	56	26	8

Crashes Per Year				Percent Reduction
Crash Type	Before HFST	First HFST Treatment	Second HFST Treatment	
	(1/1/2010 to 10/31/2012)	(12/1/2012 to 9/30/2015)	(11/1/2015 to 6/30/2017)	
wet	17.6	1.8	0.8	93%
Off Roadway	2.1	0.7	0.4	74%
Total Crashes	19.8	9.2	3.2	69%
