# High Friction Surface Treatment Guidelines

*Project Selection, Materials, and Construction*

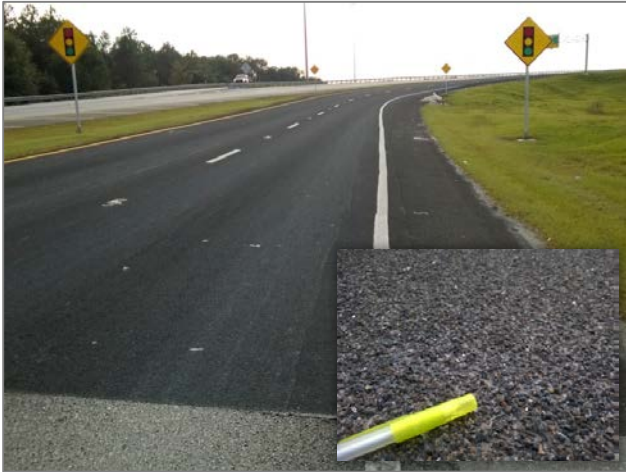
FIGURE 1 – High friction surface treatment.

High friction surface treatment (HFST) is a safety-first pavement treatment intended to restore and maintain pavement friction to reduce crashes. It is a thin layer of high-quality polish-resistant aggregate bonded to the pavement surface with polymer resin binder, specified in FDOT Section 333.

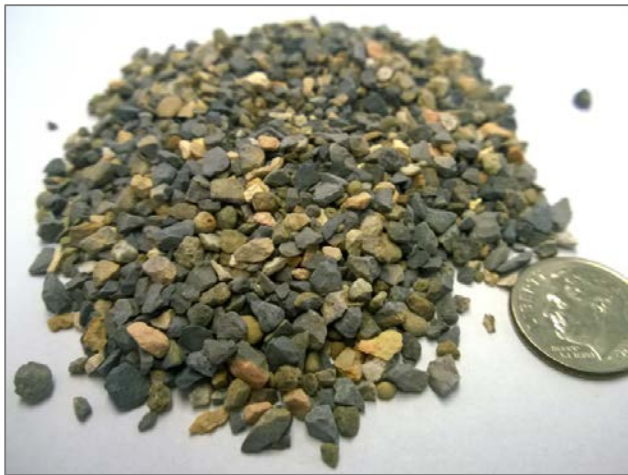
**FIGURE 4 – Calcined bauxite, crushed and graded.**

The aggregate gradation is a very fine gravel. The maximum size is 3 to 4 mm and the minimum size is about 1 mm (95% passing No. 6 sieve and 5% passing No. 16). If a larger gradation were used, the HFST would require more resin binder without any added safety benefits.

Calcined bauxite is mandated in Section 333. The critical aggregate properties here are 1) a low aggregate abrasion value (20% max) and 2) a high aluminum oxide ( $\text{Al}_2\text{O}_3$ ) content (86% minimum).

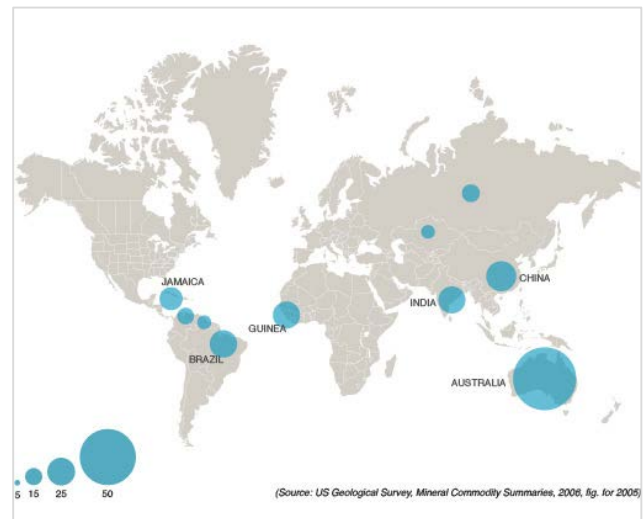
**FIGURE 5 – Bauxite sources.**

Calcined bauxite is an imported product in the United States. Raw bauxite is primarily mined to produce aluminum. The leading bauxite producers are Australia, China, Brazil, India, Guinea, and Jamaica. When raw bauxite is heated to high temperatures (1,000 to 1,500°C), it undergoes calcination, increasing in physical hardness. Calcined bauxite is shipped to the states and then crushed to size, washed, dried, and bagged before shipping to regional business like the HFST installer. At present, virtually all the calcined bauxite we use comes from

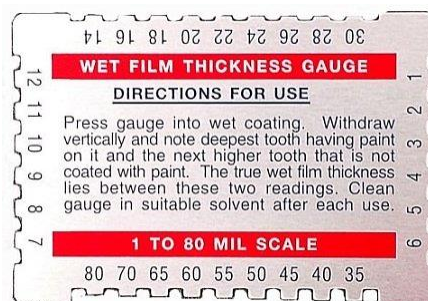
FIGURE 6 – Wet film thickness gauge.

- **Resin binder application rate** – Equipment settings to achieve correct resin binder thickness. In production, the application rate will be measured by material weights and flow rates in the equipment. Beforehand, this rate should be verified with a wet film thickness gauge. (FIGURE 1) In a couple locations, use this simple device to check the film thickness prior to spreading aggregate.

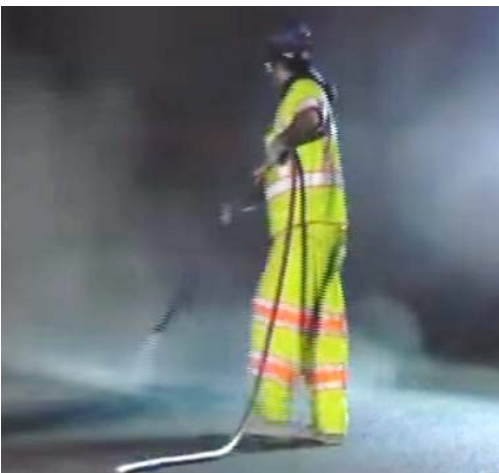
**FIGURE 7 – Proper air wash technique.**

- Use dry compressed air
- Use a minimum of 180 cfm
- Compressor oil traps must be functioning (or compressor may start misting oil!)
- Maintain air lance perpendicular and within 12 inches of the surface. (FIGURE 7)

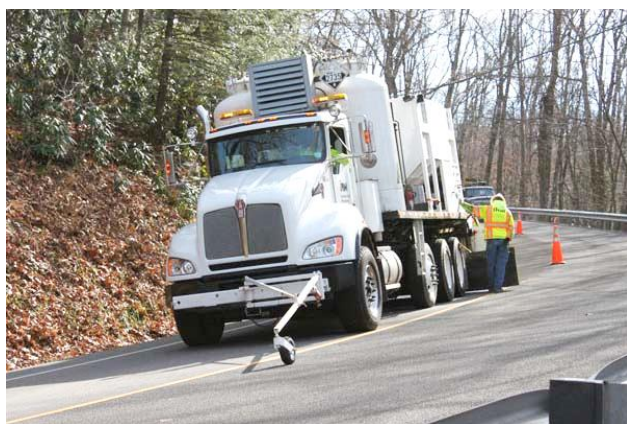
**FIGURE 9 – Continuous automated HFST applicator vehicles.**

FDOT mandates the use of a continuous automated applicator vehicle for all projects. (FIGURE 9) This automated method minimizes or eliminates problems often observed with manual application methods: inadequate binder mixing, improper and uneven binder thickness, delayed aggregate placement, and inadequate aggregate coverage. In addition, the automated process is considerably faster (2,000+ sy/hr), permitting a quicker return to traffic. Manual application is only allowed for areas less than 200 sy or where the automated equipment cannot reach.

The automated applicator must mechanically meter, mix, monitor and apply the resin binder and apply the aggregate in one uniform and continuous pass. The metering pumps may be heated to lower the viscosity. The system must be capable of applying at least a 12-ft width at the recommended rates.

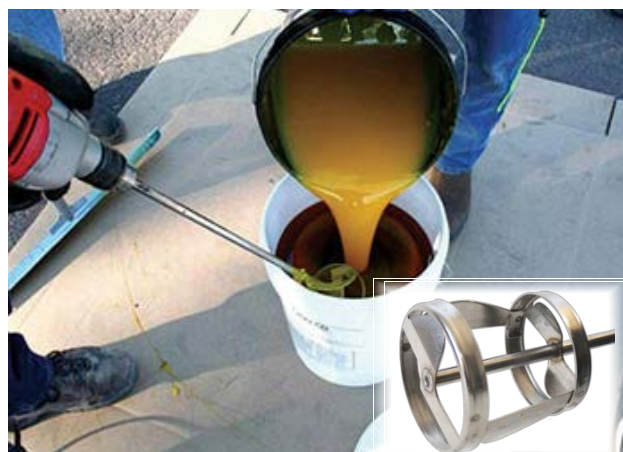
**FIGURE 10 – Electric mixer with “Jiffy Mixer” attachment.**

- Containers for mixing.
- Electric mixer.
- “Jiffy Mixer” attachments to minimize air entrainment. Use two attachments to mix each component alone in original containers and then another for mixing components together.
- V-notched neoprene squeegees (3/16”).
- Spiked shoes.
- Blower for spreading aggregate (optional).

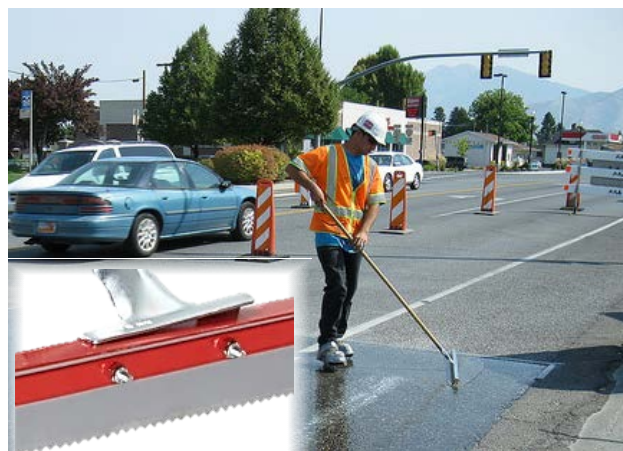
**FIGURE 11 – V-notched squeegee.**

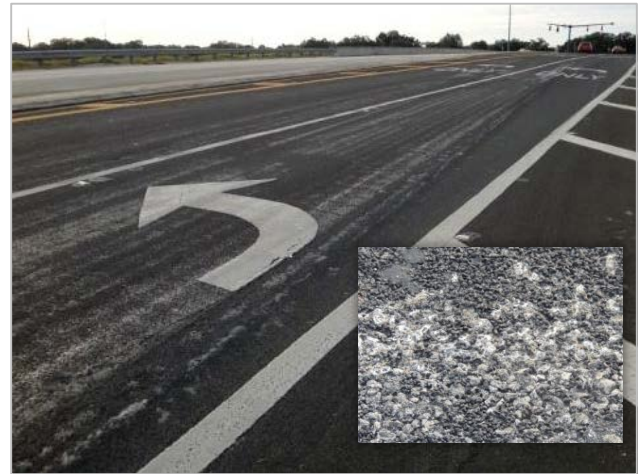
FIGURE 13 – Aggregate loss over uneven texture.

This common failure type happens when the aggregate is lost from the resin-binder. (FIGURE 13 and FIGURE 14) It is often associated with poor construction techniques.

- Resin-binder layer was too thin
  - Application rate was too low
  - Surface texture was non-uniform
  - Draindown on HMA with higher surface voids. More severe with low-viscosity resin-binder and during warmer conditions.
- Aggregate was not clean or dry

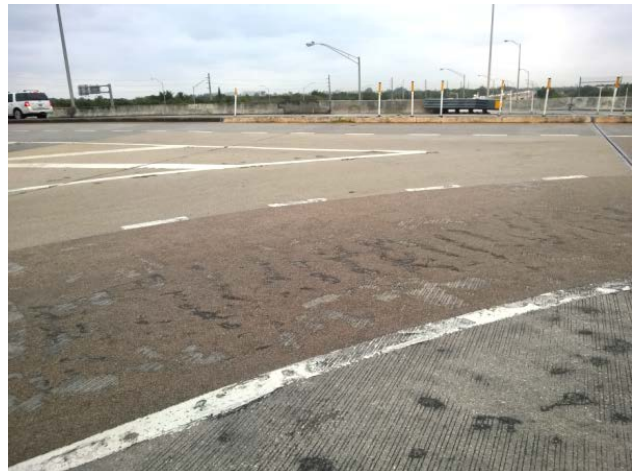
FIGURE 14 – Aggregate loss over concrete.

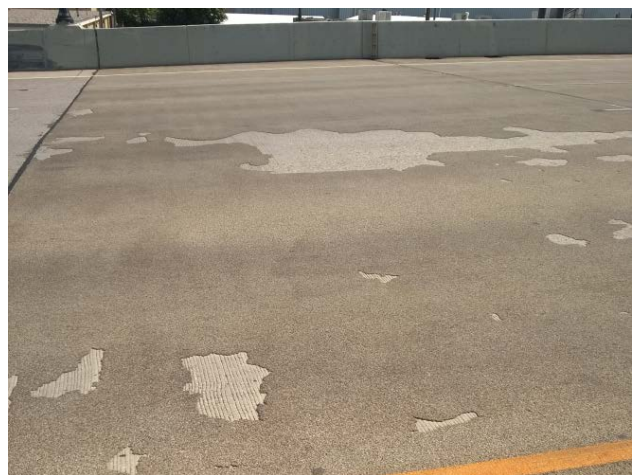
FIGURE 15 – Delamination.

Occurs when the bond between the HFST and existing surface fails, noted by the complete HFST system coming off with little or no substrate attached. Most common on concrete surfaces. (FIGURE 15)

The force that actually causes delamination is usually thermal stress. HFST has a much higher coefficient of thermal expansion than concrete and asphalt. When the bond is insufficient, this thermal cycling will break the bond and traffic break and remove the loose material.

- Concrete shot blasting not adequate.
- Surface contamination during construction.
- Poor sweeping and air-wash practices.
- Moisture during construction. May not be visible on surface but is inside surface voids.

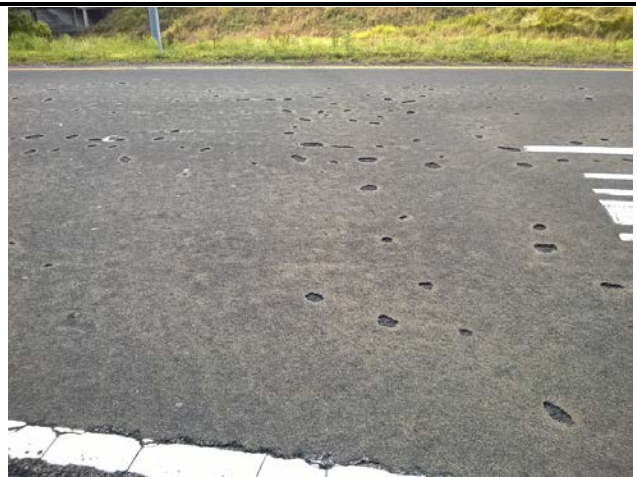
FIGURE 16 – Widespread localized failures due to poor binder mixing.

Dramatic failure mode where the resin binder does not properly cure. Results in aggregate loss, binder flushing/tracking, and in some cases localized substrate failure. (FIGURE 16 through FIGURE 18)

- Incorrect resin binder proportioning.
- Poor resin-binder mixing (most likely).

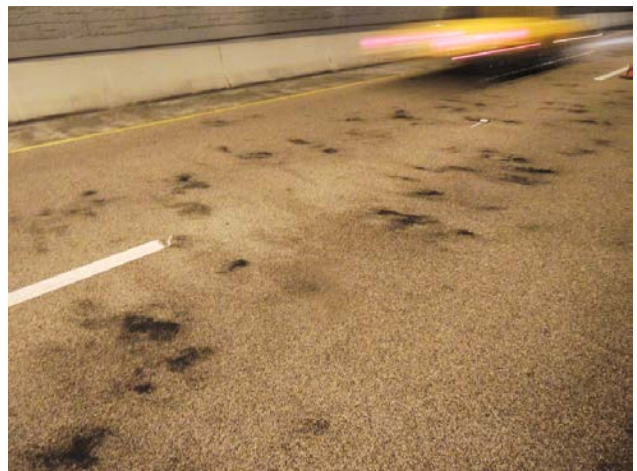
FIGURE 17 – Soft splotchy areas shortly after construction.

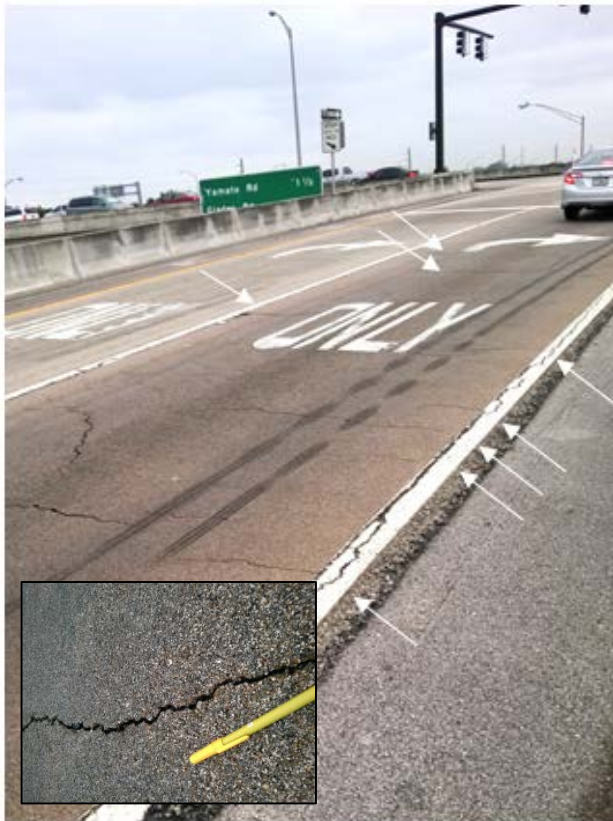
**FIGURE 20 – Substrate top-down tearing at a signalized approach (transverse cracking).**

Manifest as a cracking distress. When HFST is applied to the surface, the shear transferred into the pavement from breaking and turning vehicles increases. This can accelerate deterioration of weak substrates. (FIGURE 19 and FIGURE 20)

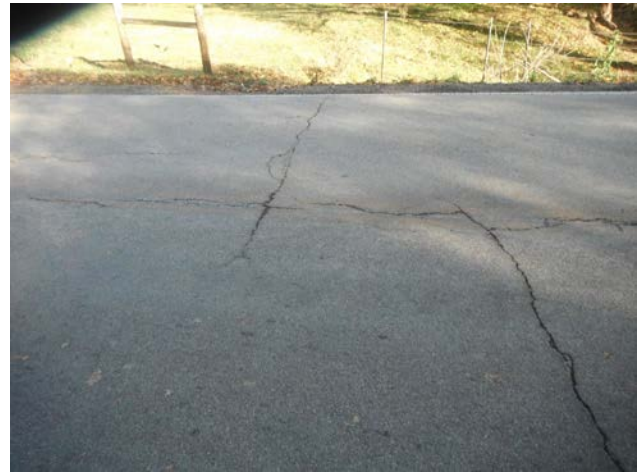
**FIGURE 22 – Reflective cracking.**

HFST has some flexibility and should resist brittle cracking under traffic. However, existing cracks will still propagate through the HFST under traffic and thermal cycling. Other than restoring the surface before HFST application, this distress is unavoidable. (FIGURE 22)
